PROPERTY CONDITION ASSESSMENT REPORT

Timberline Home Inspections. Your trusted, reliable Kootenay Inspection service!

123 Main Street
Timberline, BC A1A 1A1

Friday, April 1, 2022

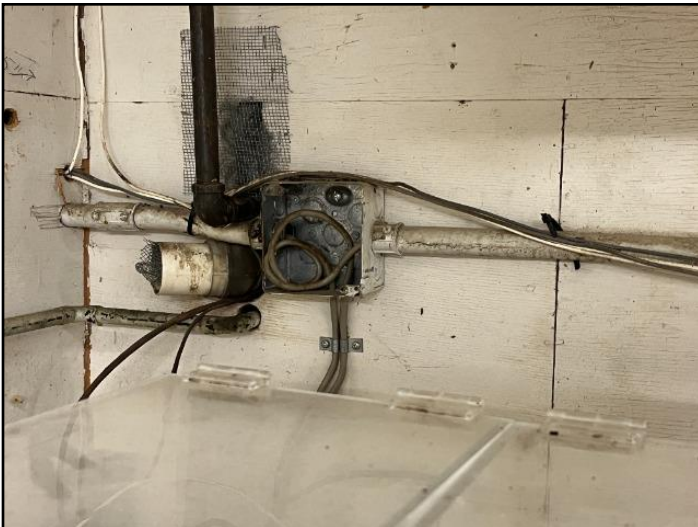
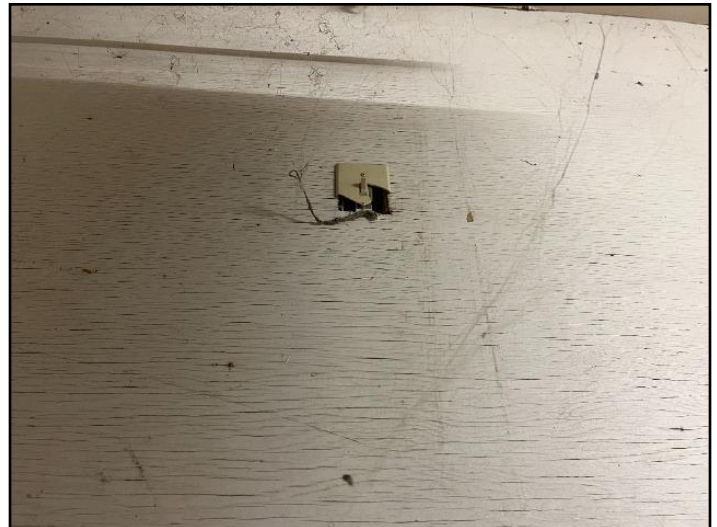
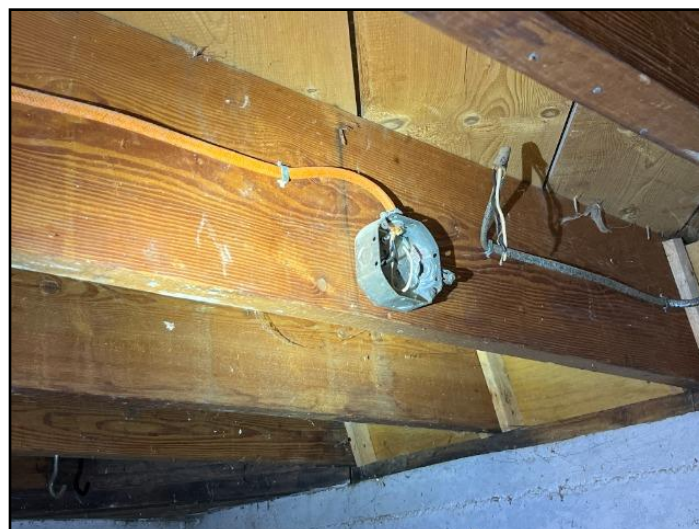
Condition: • Missing on switches, outlets and junction boxes

Missing/damaged cover plates on various switches, receptacles and junction boxes. Recommend installing cover plates.

Implications: Electric shock

Missing on switches, outlets and junction...

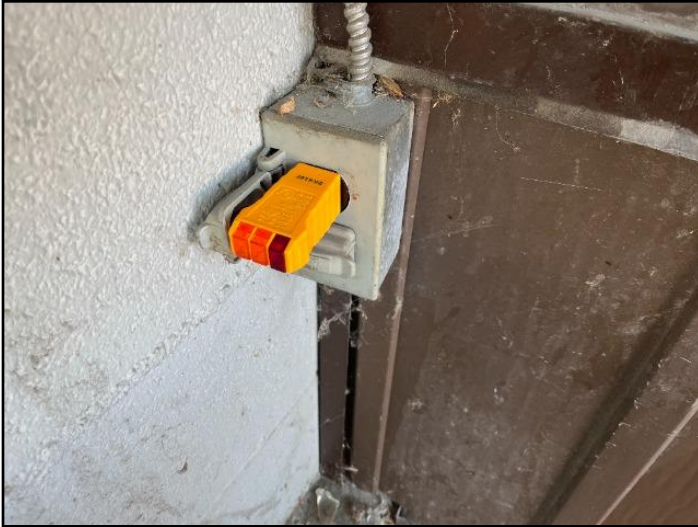
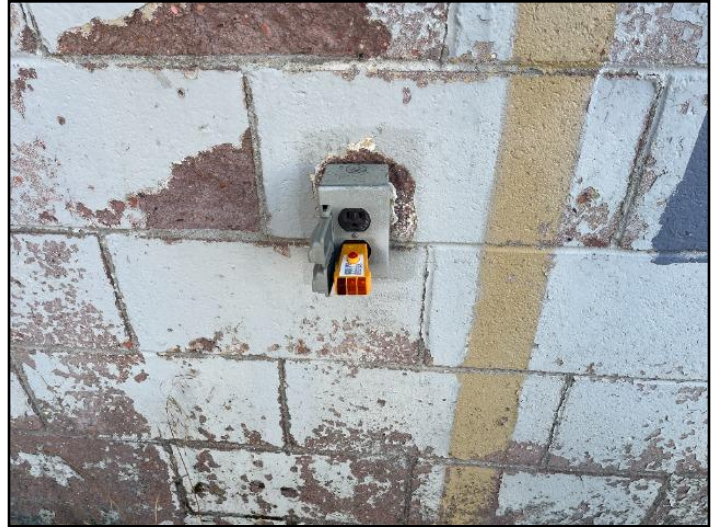
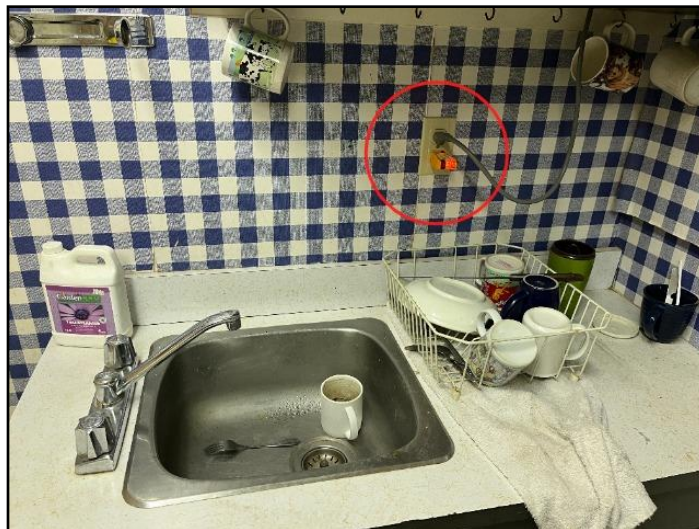
Condition: • Exterior receptacles and receptacles within 5 feet of a sink/water source are recommended to be GFCI protected, as well as receptacles that power a sump pump.

Implication(s): Electric shock

GFCI needed

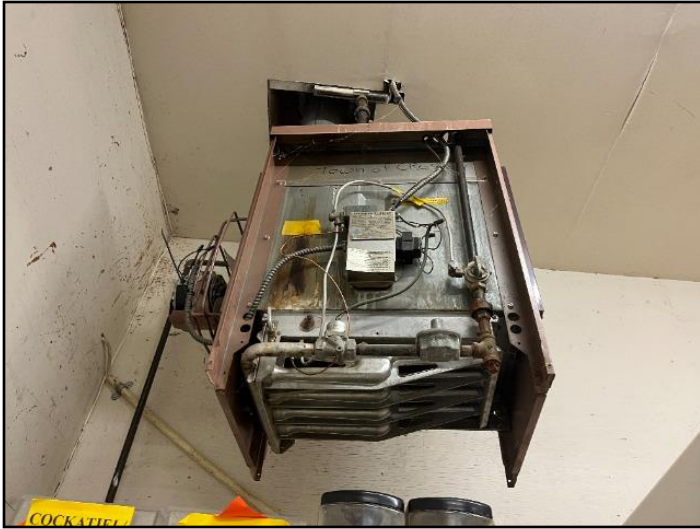
Noted poor condition ceiling mounted heater. Buildingcenter.org places date of manufacture as 1964. Past typical life expectancy. No function on day of inspection when nearby thermostat was operated. Possible hidden defects/damage. Possible equipment does not function. Recommend repairs/replacement.

Condition: • Poor

Poor

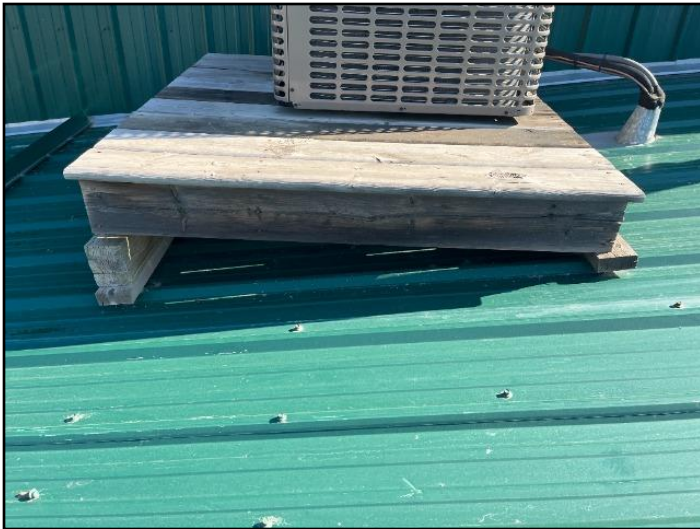
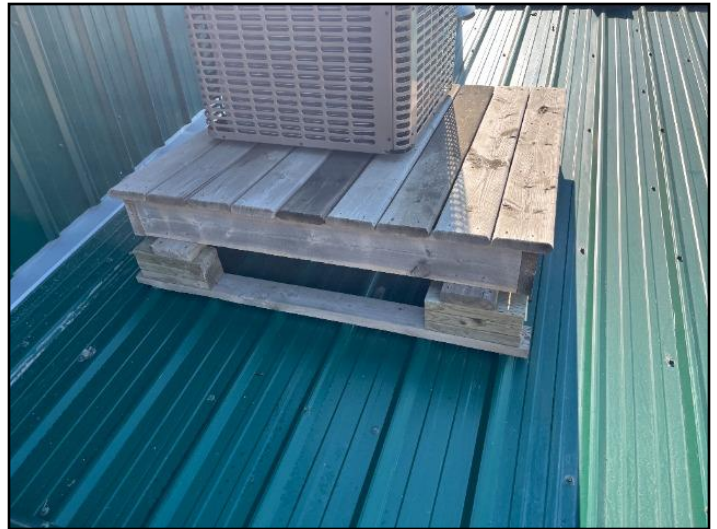
- Condition:** • Noted missing vibration reduction measures in place on the roof mounted air conditioner. Recommend installation of vibration dampeners.
- Implication(s):** Damage to roof membrane. Nuisance from noise
- Location:** Roof
- Task:** Improve
- Time:** Upon Possession

Missing vibration dampeners

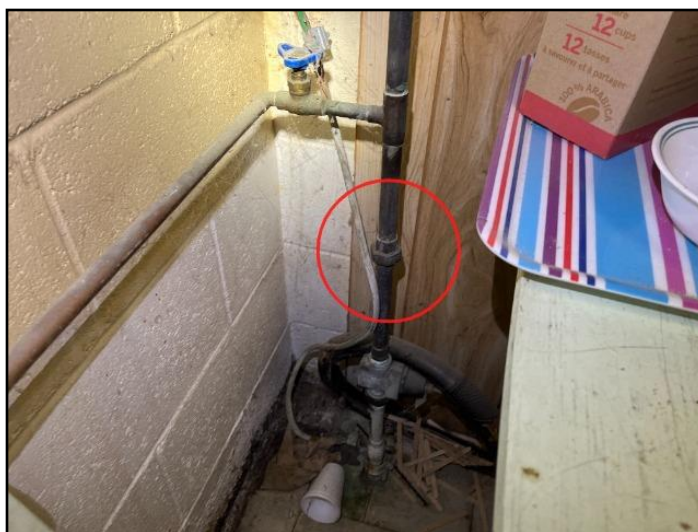
Condition: • Backflow prevention device missing at the main domestic water service entrance

Implication: Possible contamination of municipal water supply

Backflow prevention device missing at the...

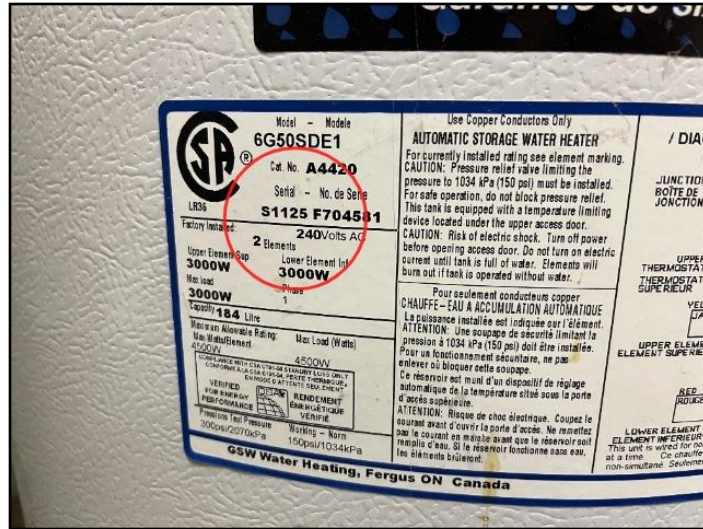
Condition: • Approaching the end of its expected useful life

Noted the date of manufacture on the hot water tank as 2011. 11 years. Typical life expectancy 8-12 years. Recommend budgeting for replacement.

Near end of typical life expectancy

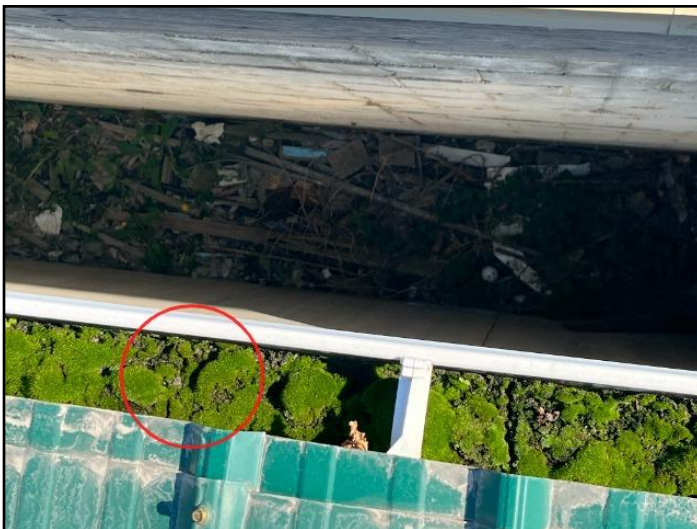
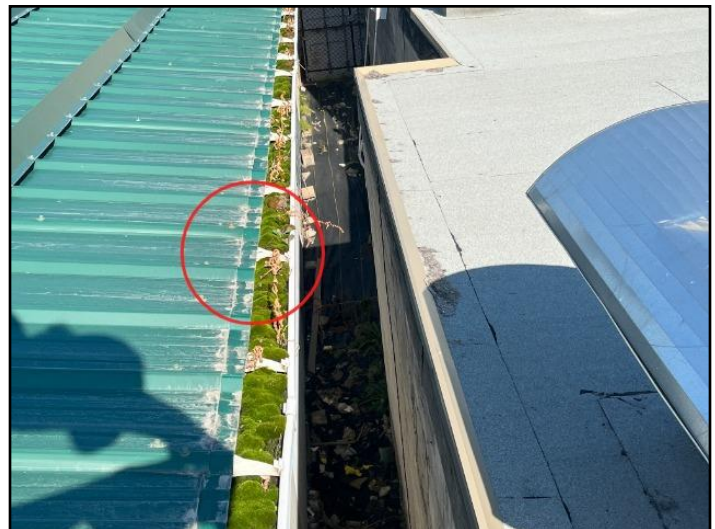
Condition: • Poor condition

Noted damaged/clogged gutters throughout the exterior. Recommend cleaning and repairing the gutters.

Implication: Water damage to structure and materials.

Poor condition

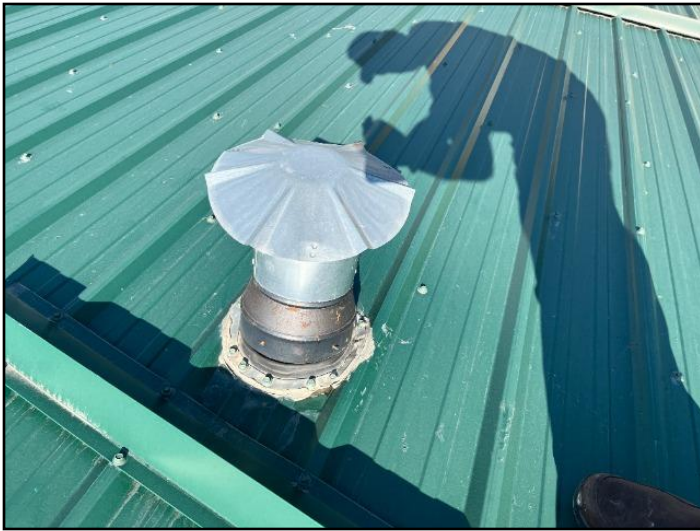
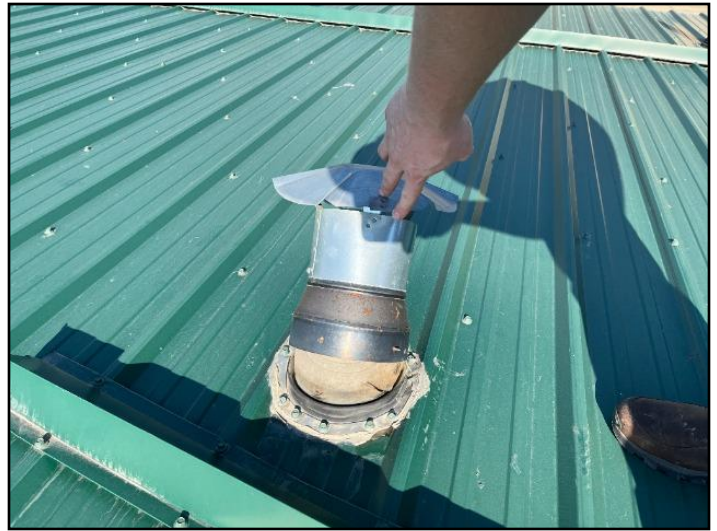
Condition: • Leaning

Noted a loose chimney fixture. Possible hidden damage. Recommend repairs.

Implications: Damage to materials. Water ingress.

Leaning

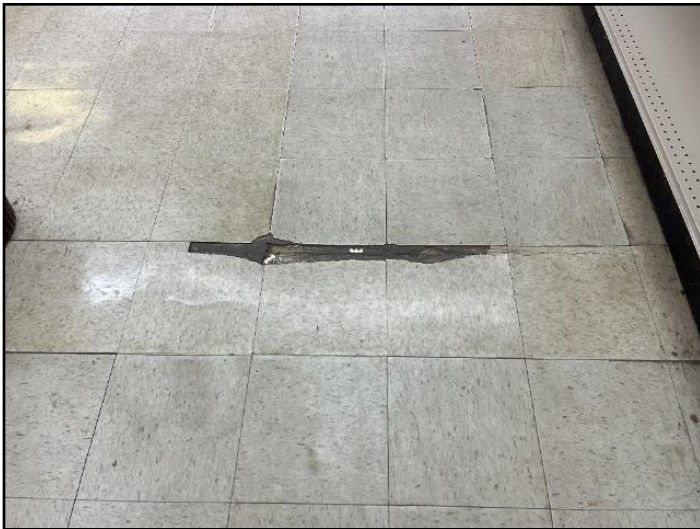
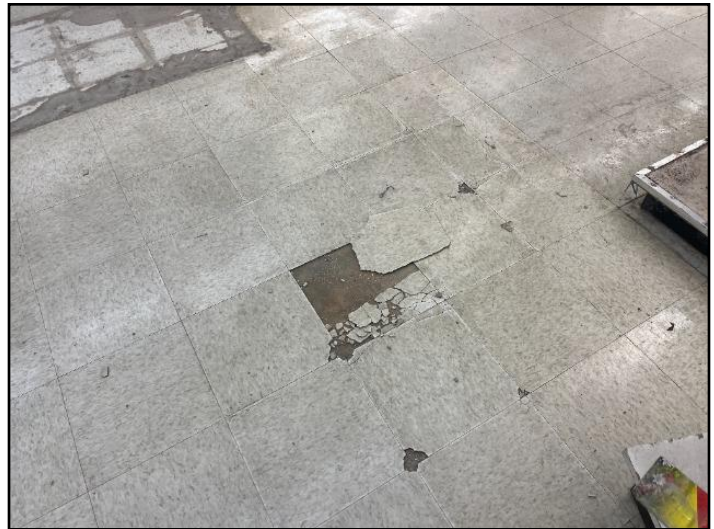
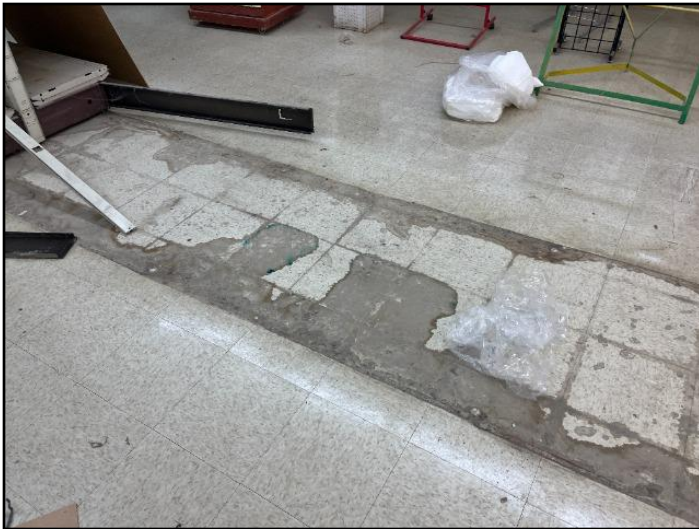
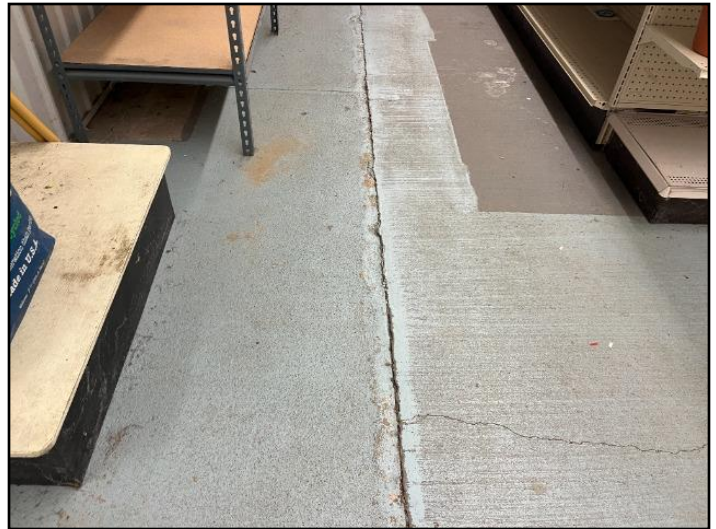
- Condition:** • Deteriorated
- Noted deteriorated and damaged flooring throughout the retail area. Noted concrete cracks in the retail areas.
- Implications: Tripping hazards. Possible hidden damage.
- Location:** Throughout retail area
- Task:** Repair/Replace
- Time:** Upon Possession

Deteriorated

Cracks

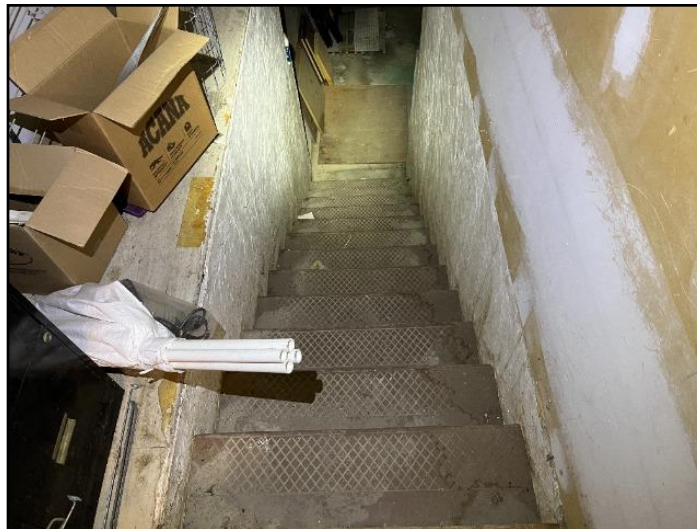
Condition: • Missing

Noted a missing handrail to on the basement access stairs. Recommend adding a handrail.

Implications: Falling hazard.

Missing

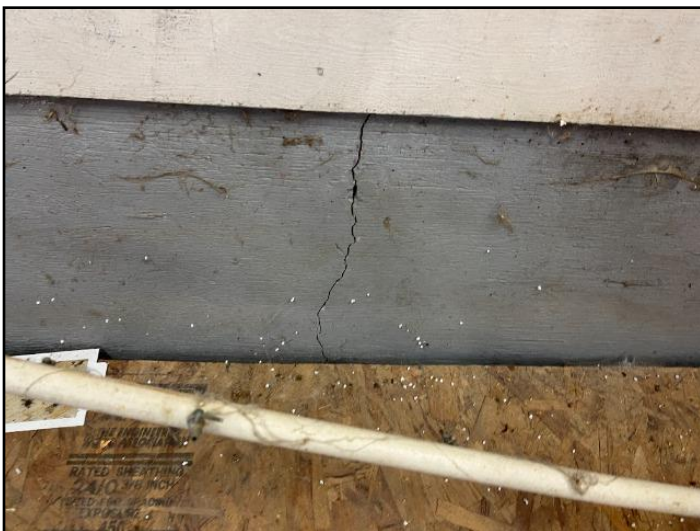
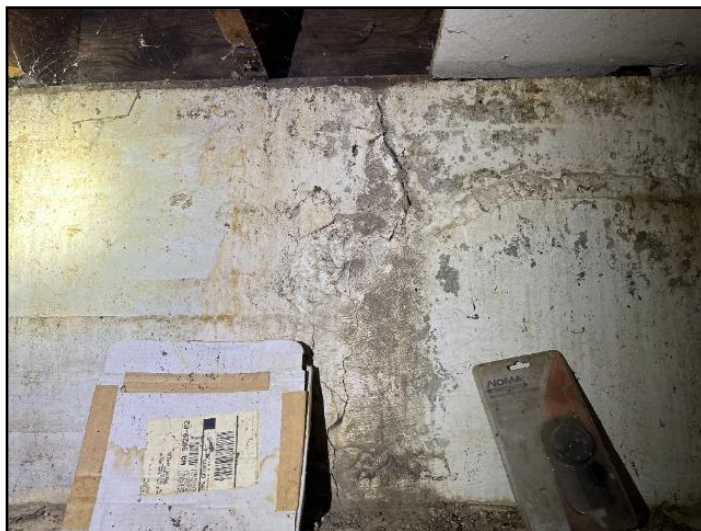
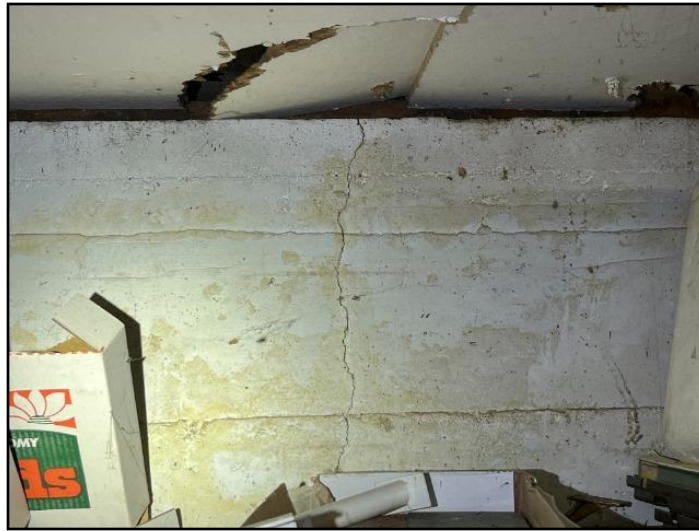
Cracks of increased size noted throughout the poured concrete foundation, where visible. Recommend repairs by a qualified concrete repair specialist. Possible hidden damage/defects.

Condition: • Settlement cracks noted

Settlement cracks noted

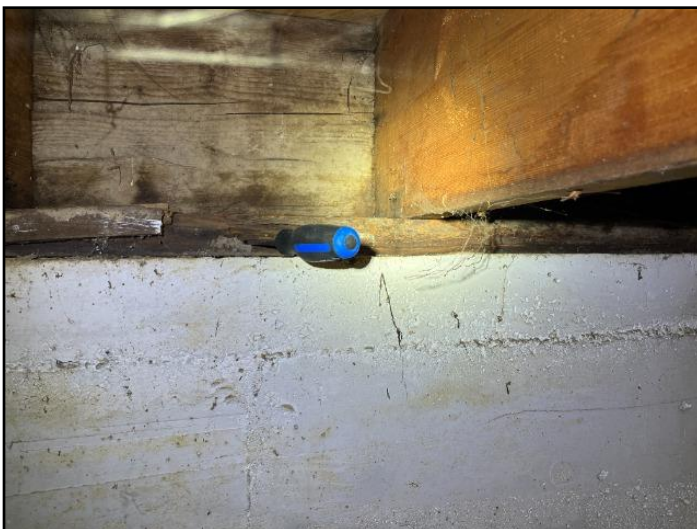
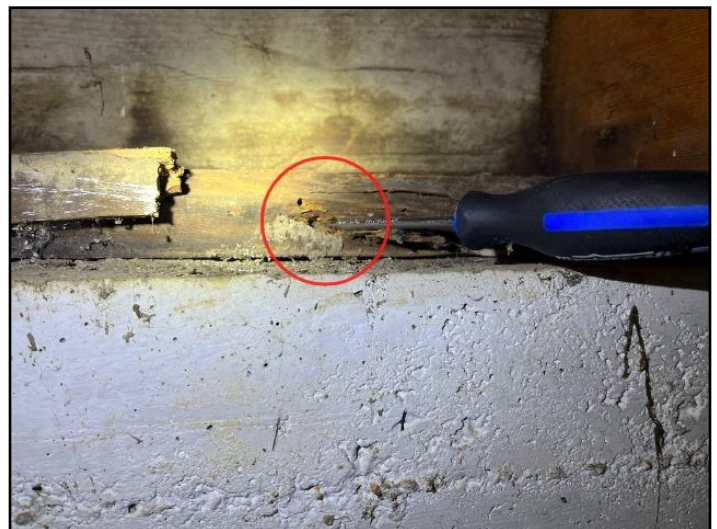
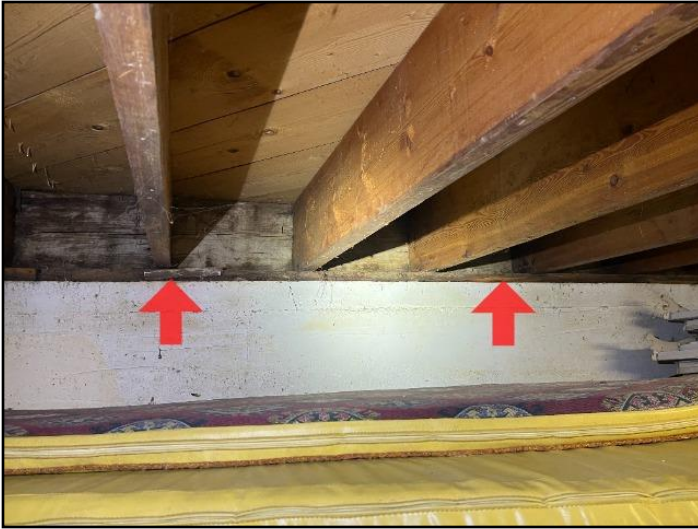
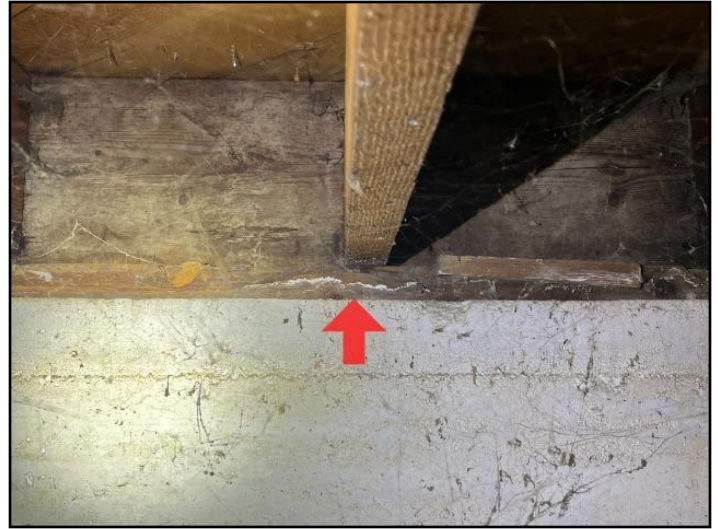
Noted sill plate rot on the East basement wall. Possible other hidden damage. Recommend repairs by a qualified Carpenter.

Condition: • Localized rot

Implications: Costly repairs. Reduced structural integrity.

Localized rot

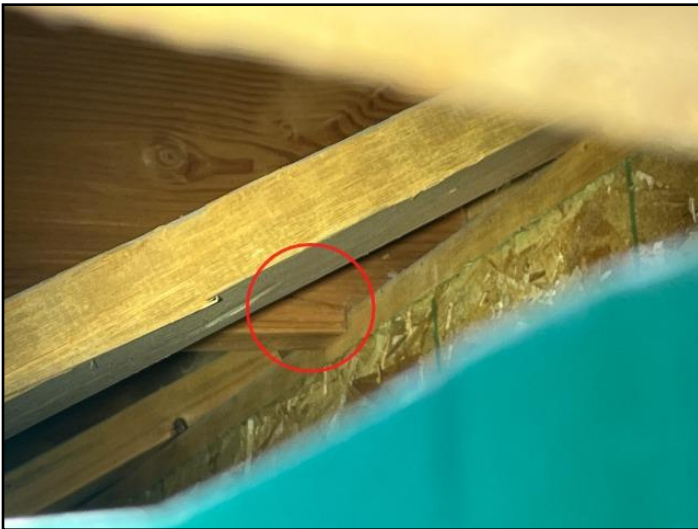
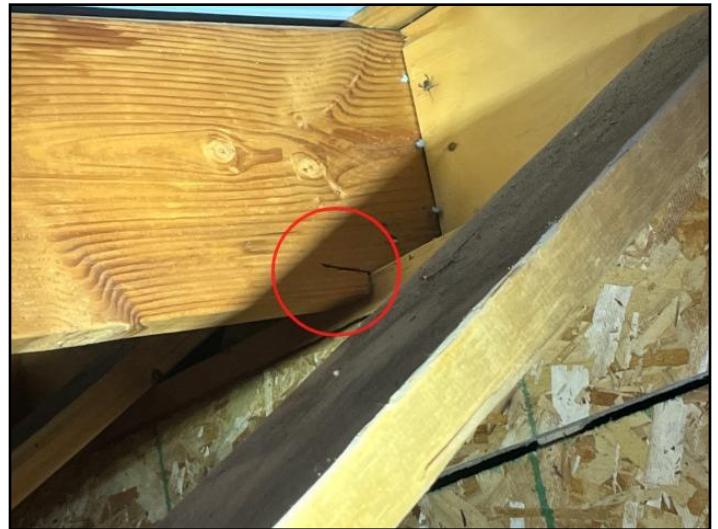
Condition: • Damaged

Noted a damaged/split roof support rafter in the East exterior attic space, visible from the attic hatch. Recommend repairs.

Implications: Reduced structural integrity. Possible damage to structure

Damaged

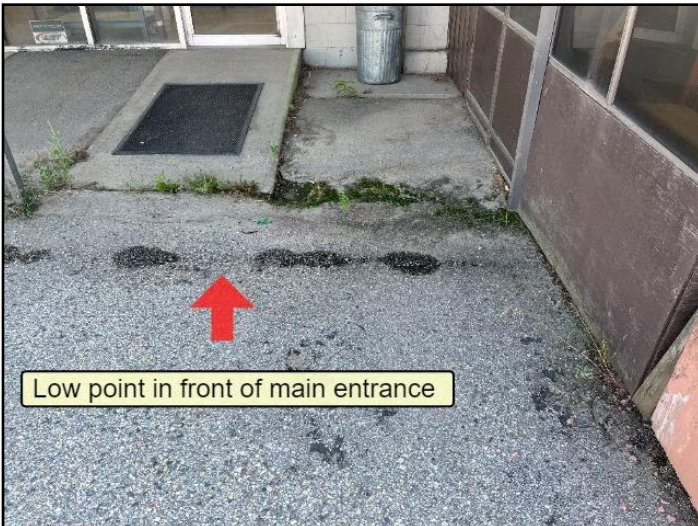
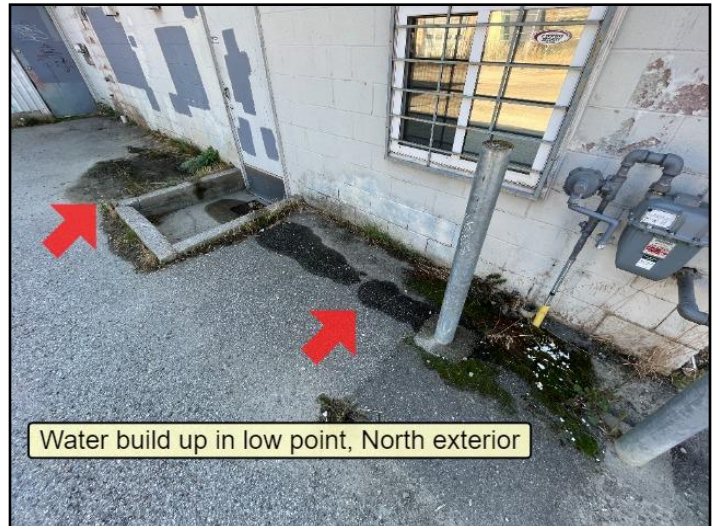
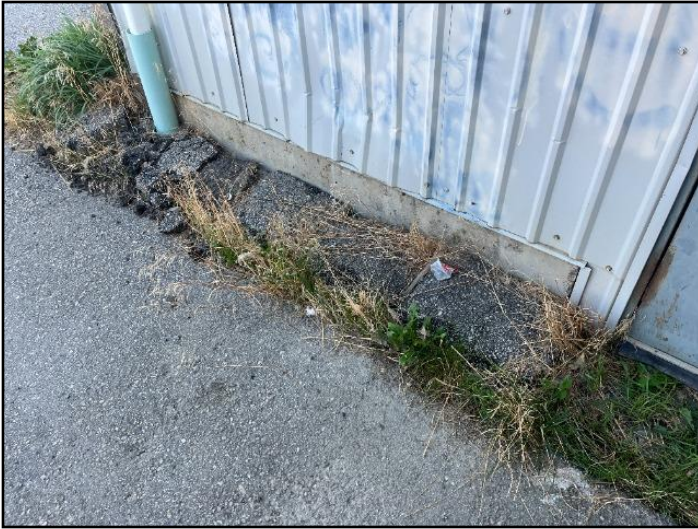
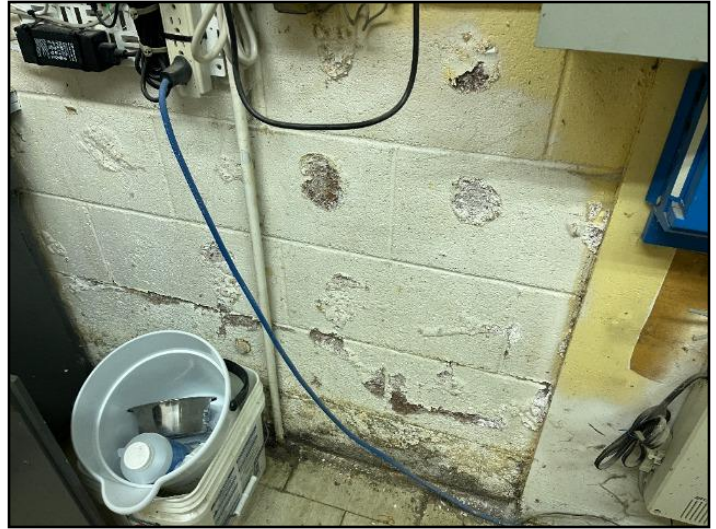
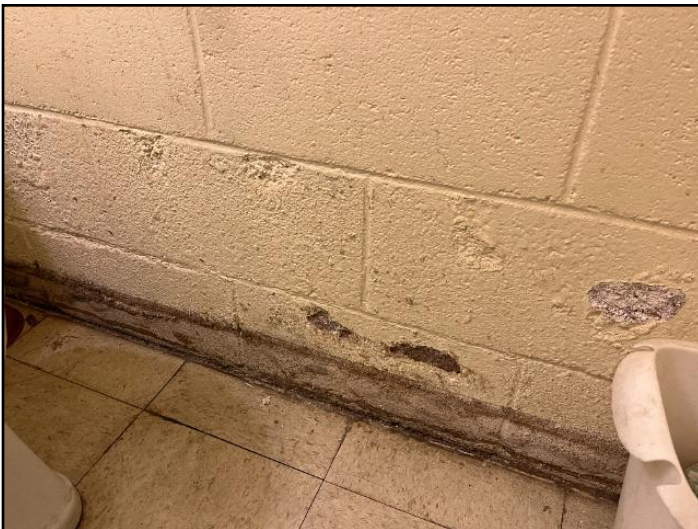
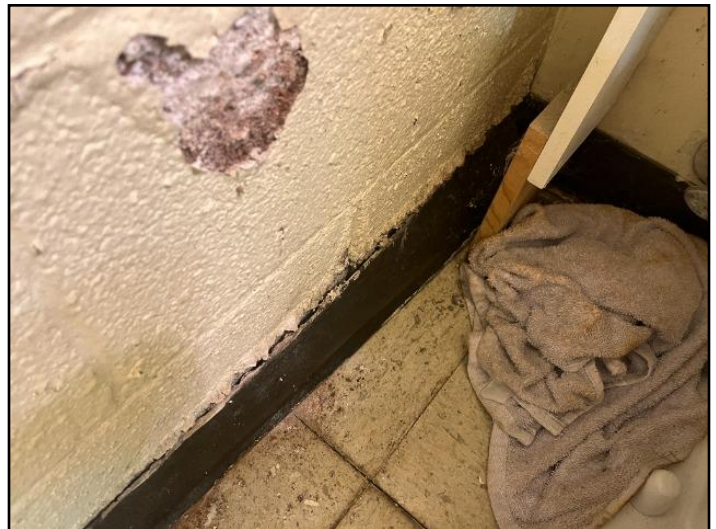
Condition: • Improper grading

Improper slope and drainage in various locations around the exterior perimeter. Evidence of moisture penetration/interior damage on the North wall. Recommend repairs.

Implications- Water damage to structure and finishes.

Improper grading

Improper drainage

Moisture penetration/damage on interior

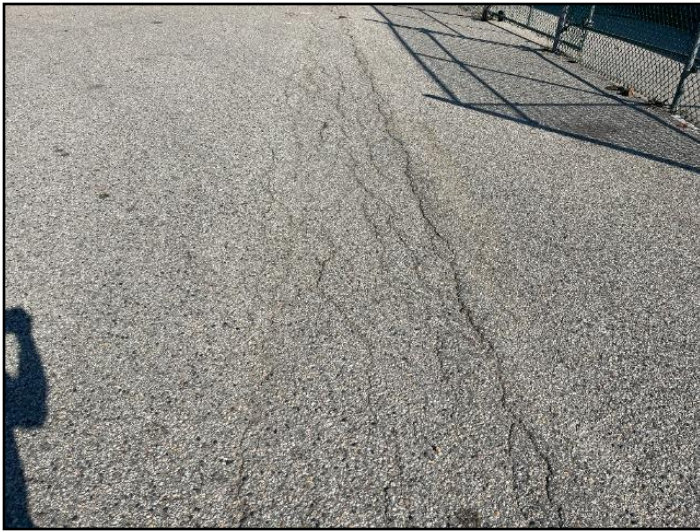
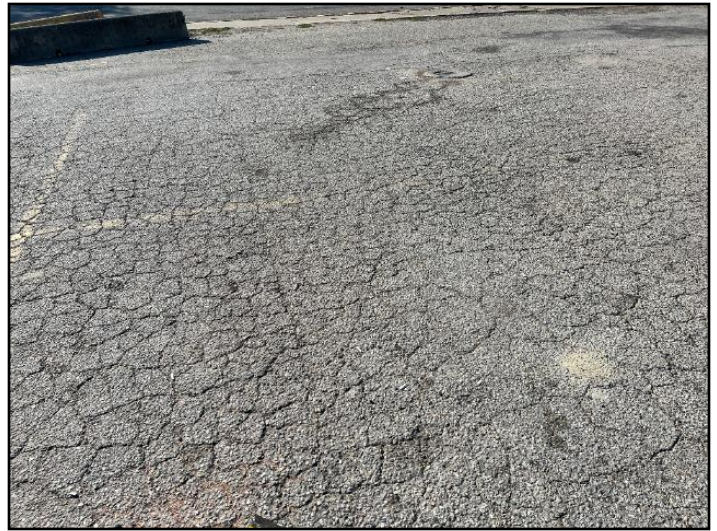
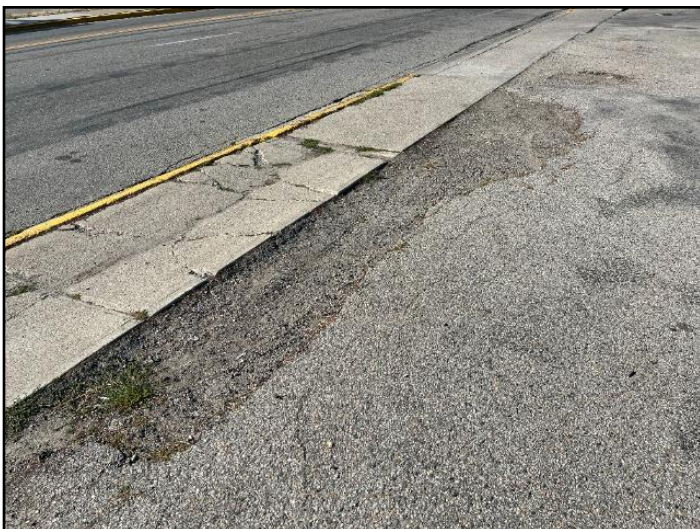
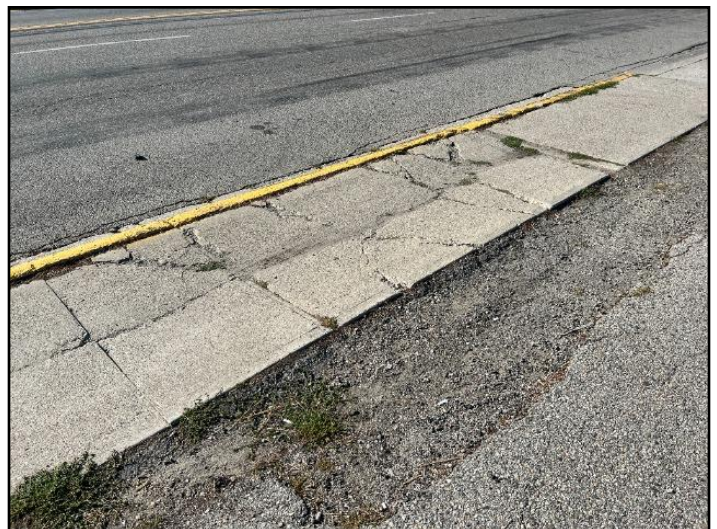
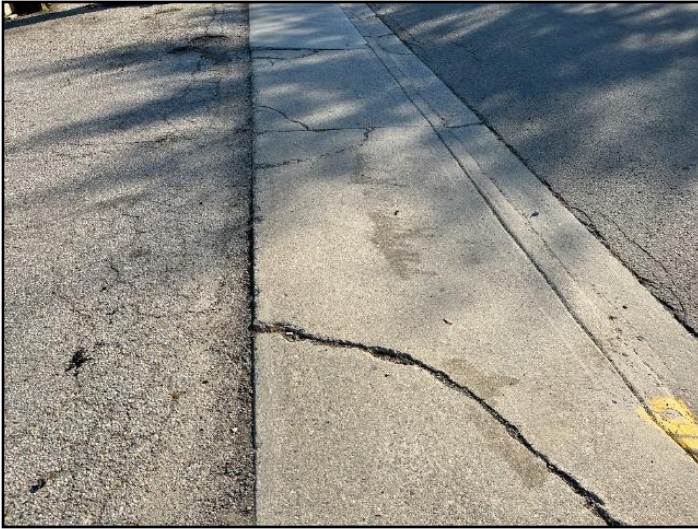
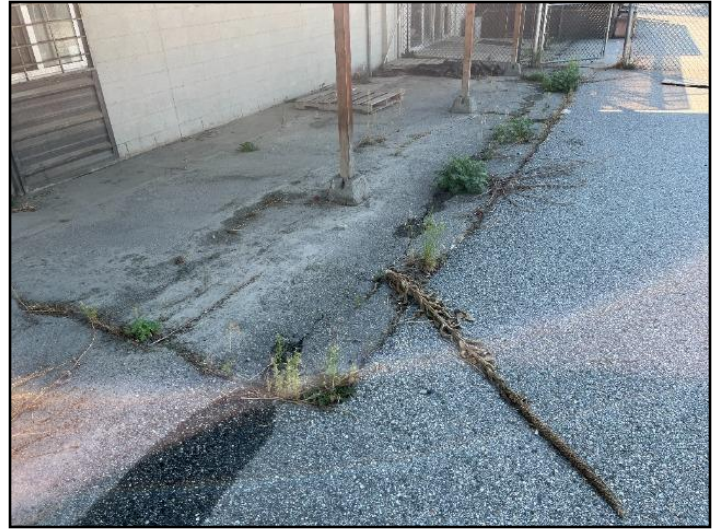
Noted the asphalt pavement is aging. Noted damaged concrete sidewalks. Regular repairs are recommended.

Condition: • Local surface deterioration

Implications- Deteriorated asphalt and sidewalks may become unusable for vehicles and unsafe for pedestrians. Possible costly repairs.

Local surface deterioration

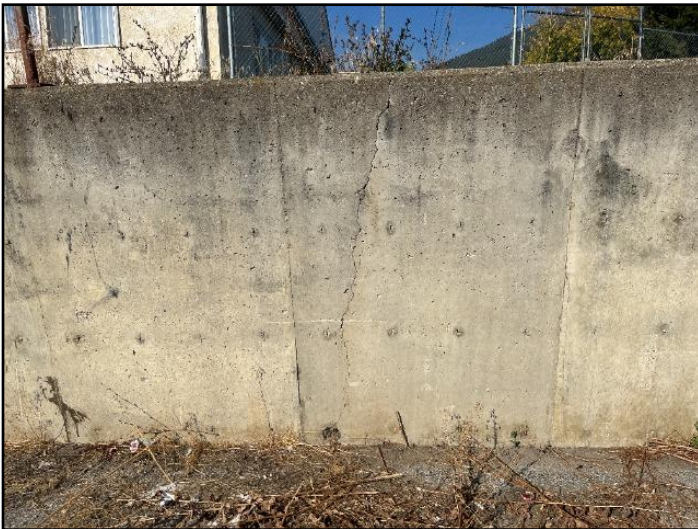
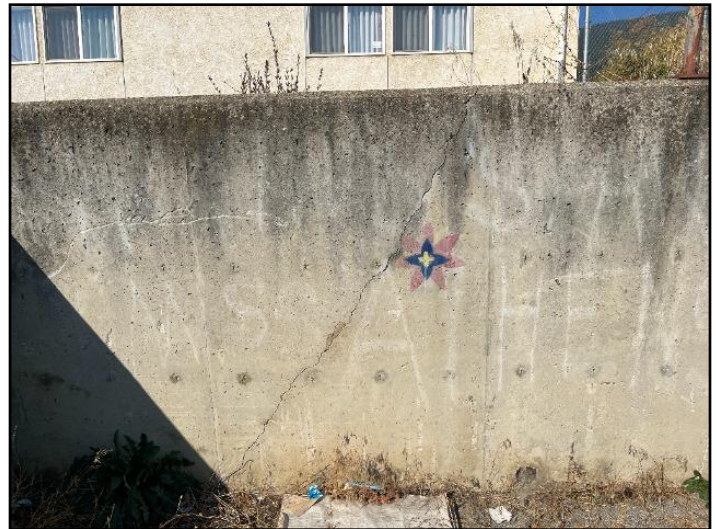
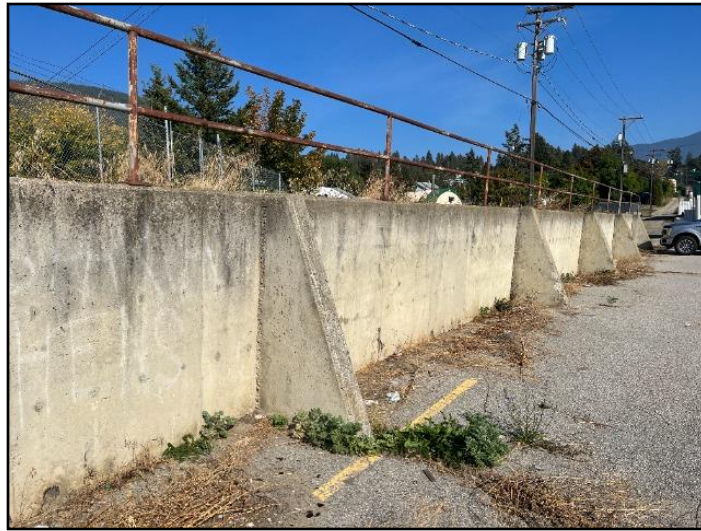
Noted the retaining wall on the North side of the West exterior parking lot is leaning and cracked. Additional support members appear to have been added. Recommend consultation with the City on determining retaining wall ownership/responsibility.

Condition: • Leaning

Cracked

Leaning
