YOUR INSPECTION REPORT

Timberline Home Inspections. Your trusted, reliable Kootenay Inspection service!

123 Main Street
Nelson, BC V1A 1A1

Saturday, April 15, 2023

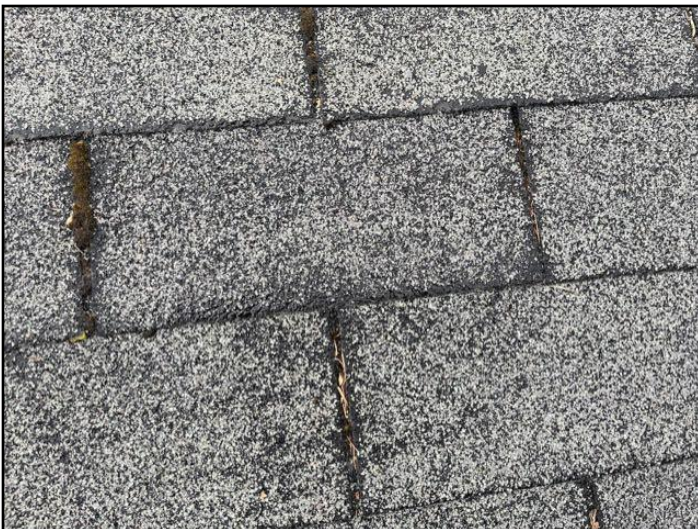
There are multiple deficiencies throughout the roof surface. Noted granule loss, patches, damaged shingles, ridges in the roof surface, and ridge shingles that are worn to the shingle mat. Roof shingles that are in this condition pose an increased risk of leaking and corresponding water damage to the structure/finishes. Recommend retaining a qualified roofer for roof replacement who will provide quotes for associated costs.

Granule Loss

Task: Replace

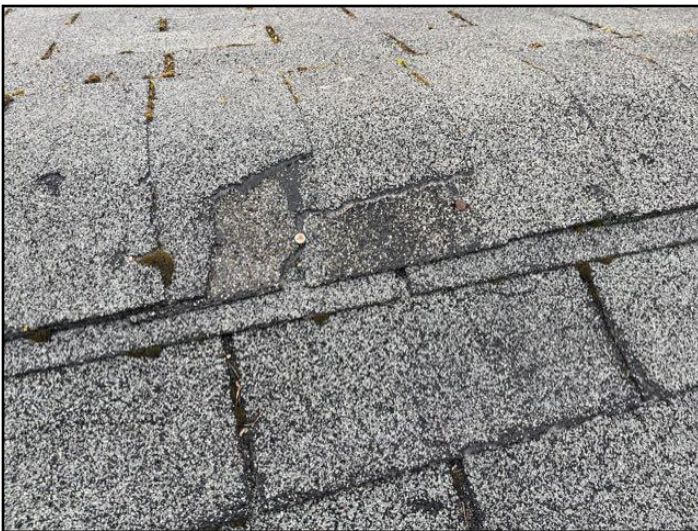
Damaged/torn

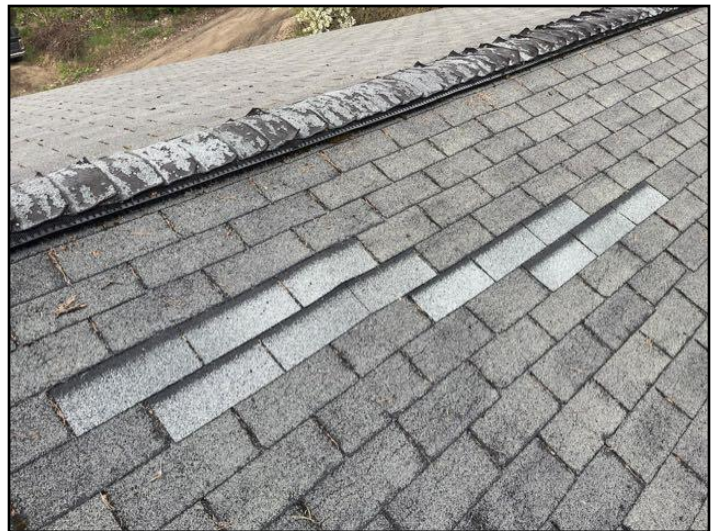
Patch

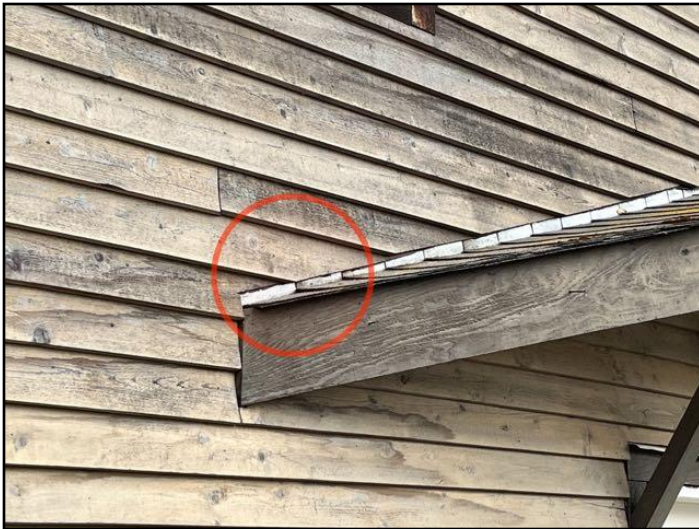
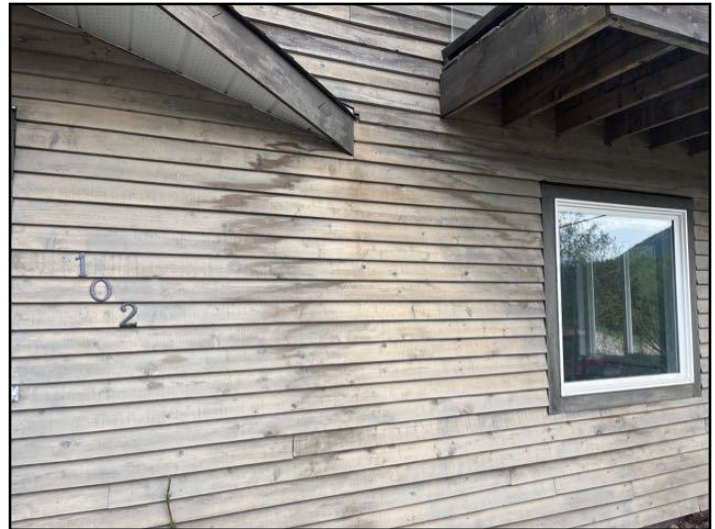
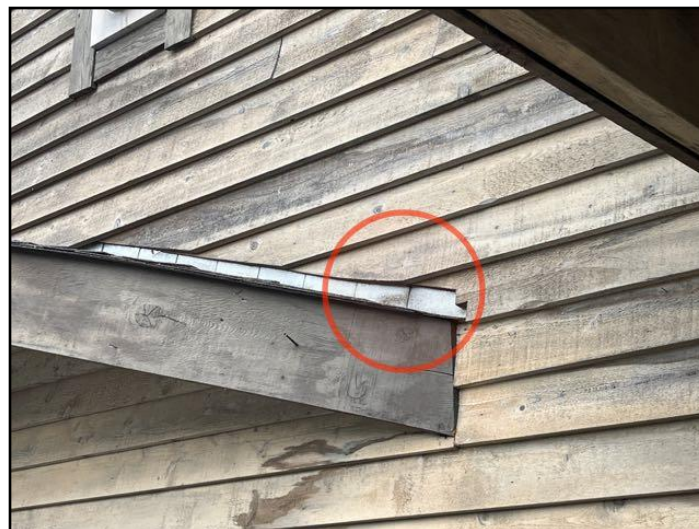
The small roof overhang on the north exterior is missing kick out flashings. There is water staining on the siding. Possible hidden damage/defects. Recommend retaining a qualified roofer to install kick out flashings.

Kickout flashing - missing

Task: Repair

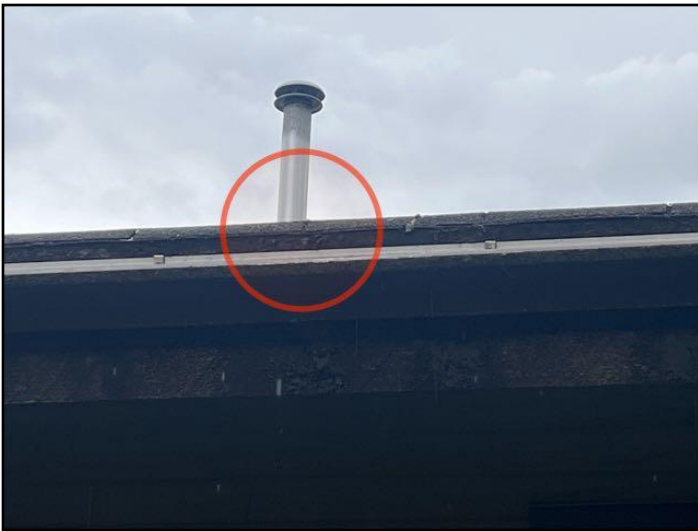
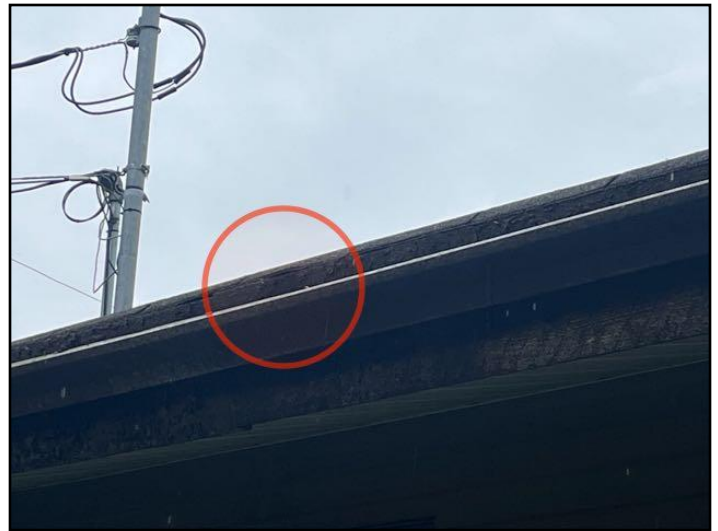
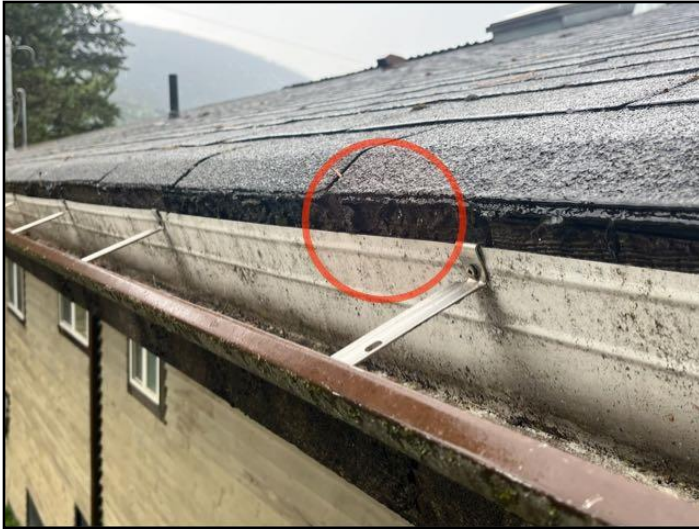
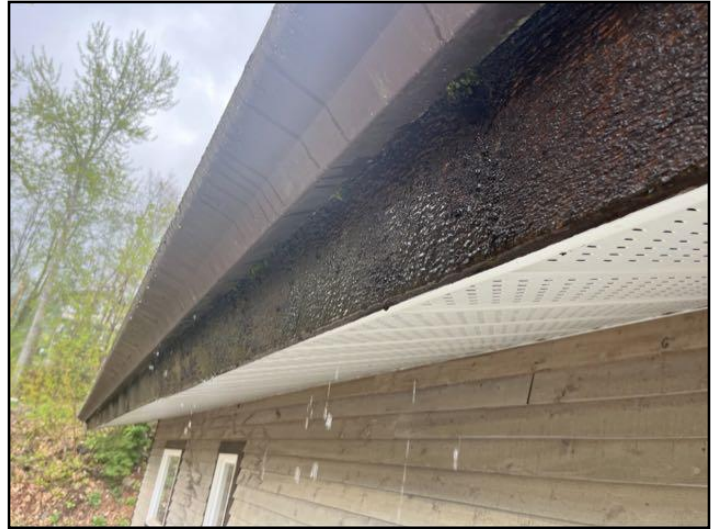
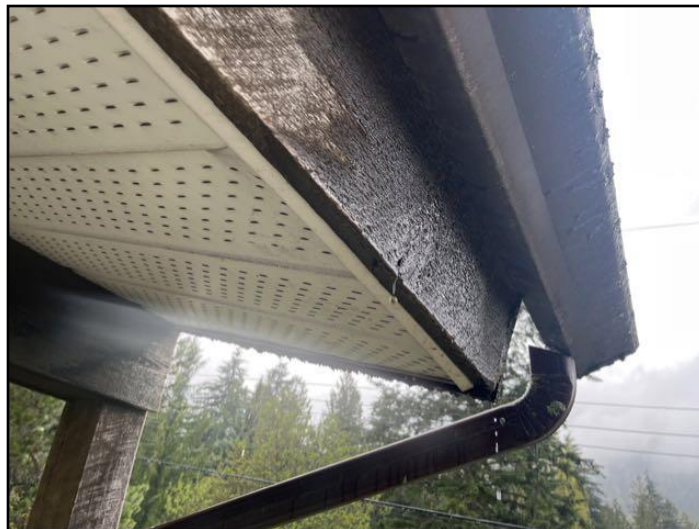
There is missing drip edge flashing. Possible hidden damage. It was raining on the day of inspection, and water was noted running behind the gutters and down the fascia boards, which are worn/damaged. Recommend retaining a qualified roofer to install drip edge flashings.

Missing

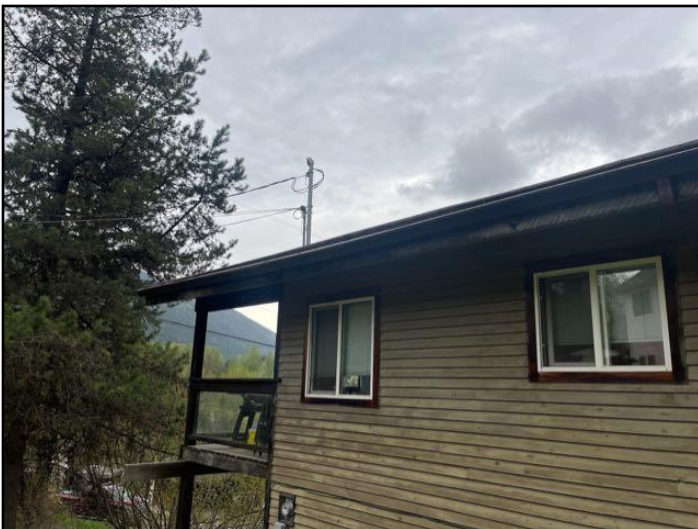
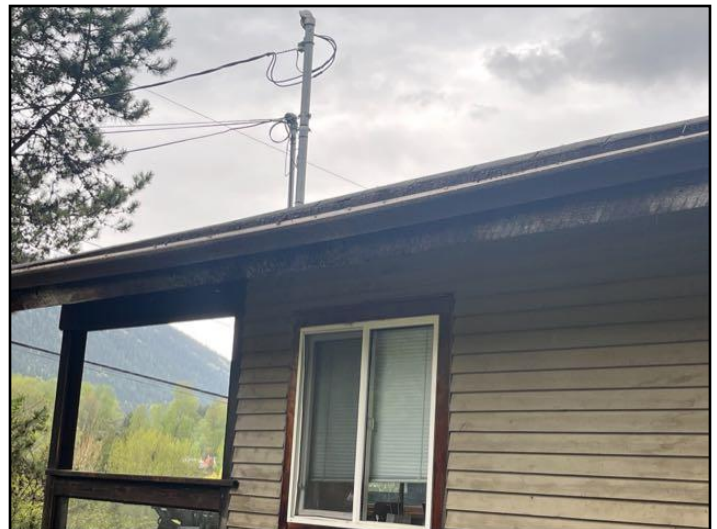
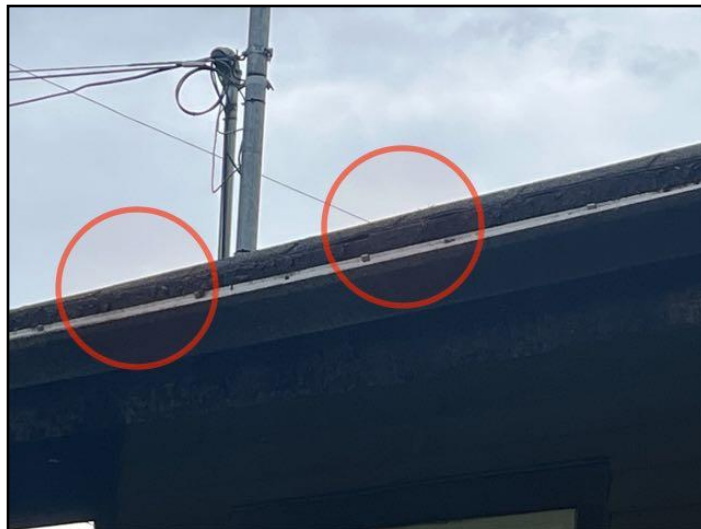
A section of the South Exterior gutter appears to be loose/pulled away from the house. The shingles on the roof do not extend past the fascia board. There is a chance that water is running behind the fascia board with possible hidden damage. Recommend immediate repairs by a qualified Carpenter/roofer who will provide quotes for all associated costs.

Loose or damaged

Task: Repair

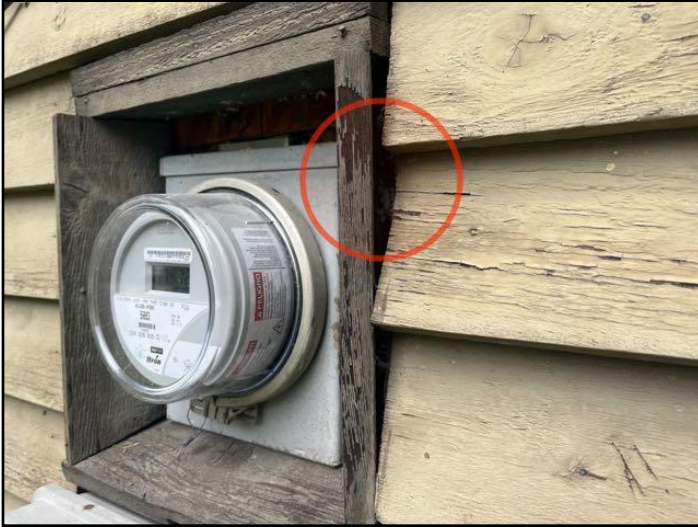
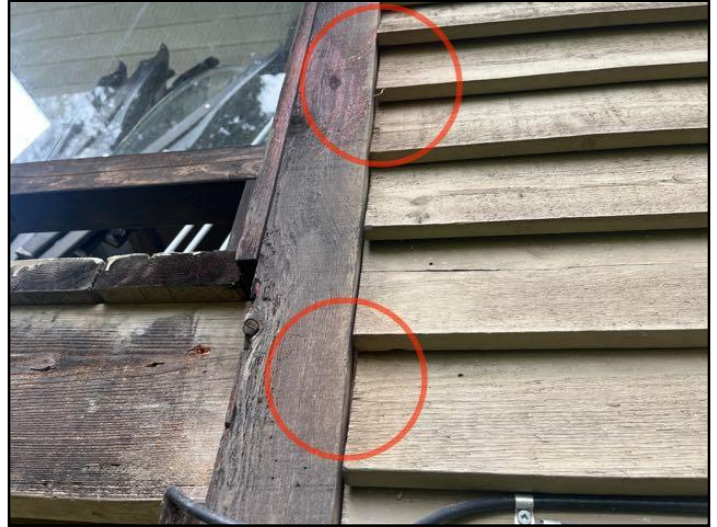
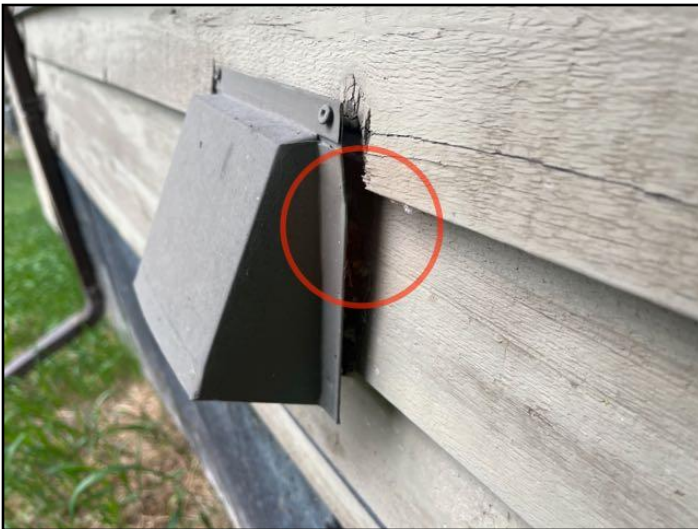
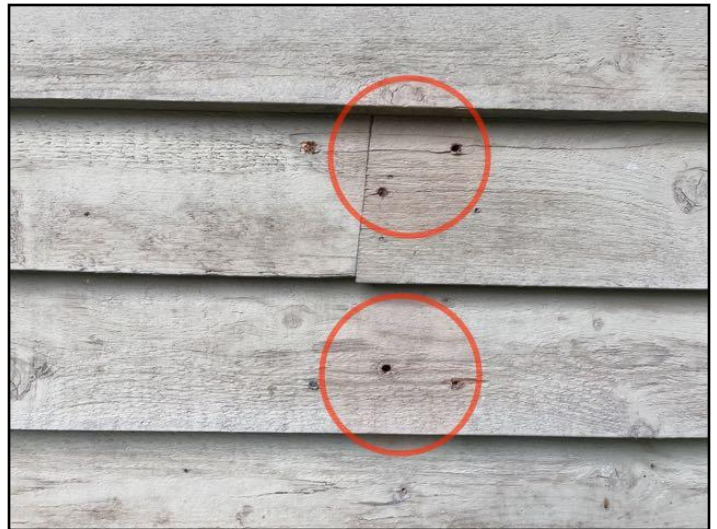
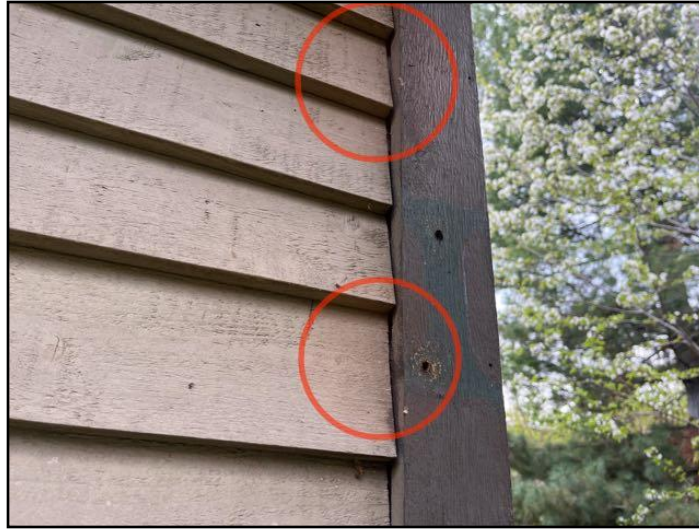
It is recommended to add a high quality putty sealant or caulking at wall penetrations, holes in the siding and at siding end joints, where missing, to reduced the chance of water and pest ingress. Possible hidden damage.

Caulking missing or ineffective

Task: Seal exterior wall penetrations

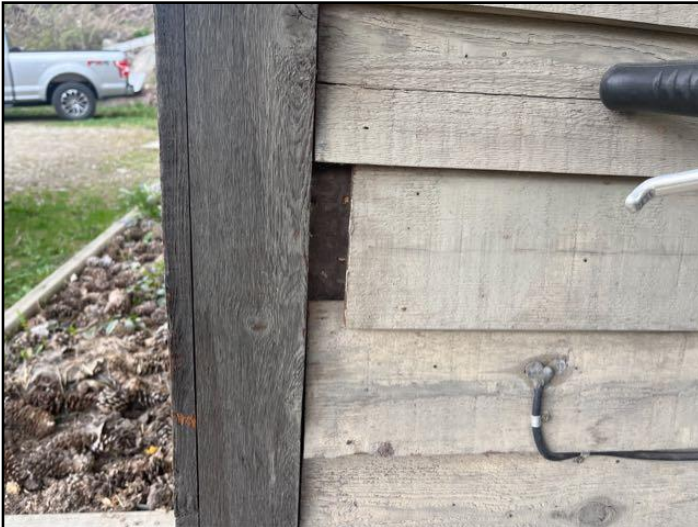
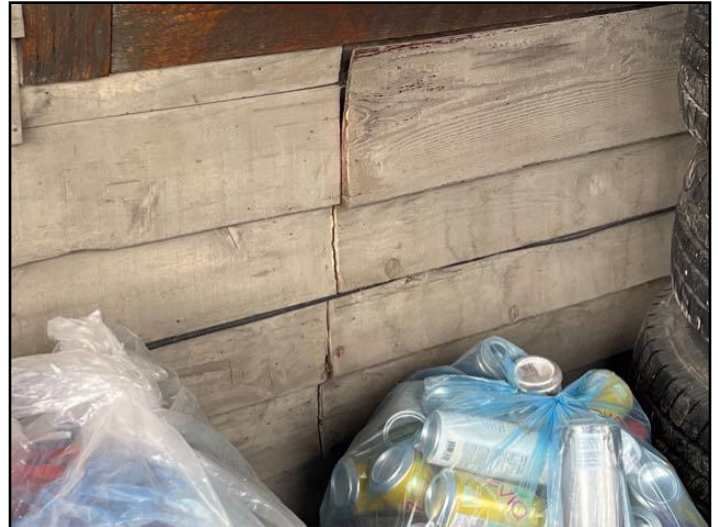
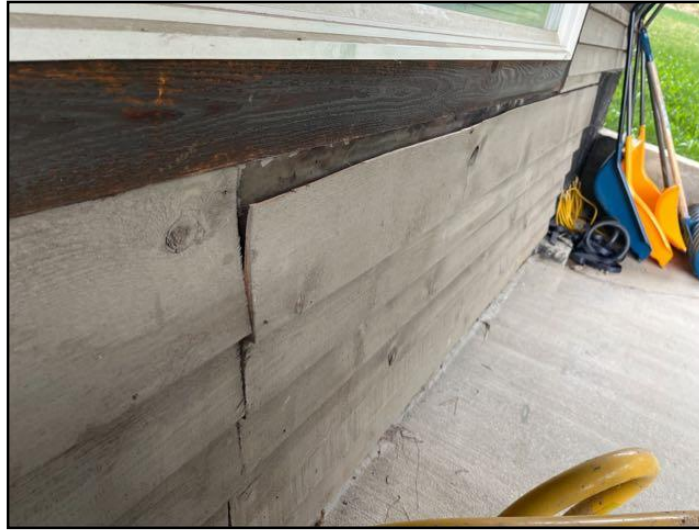
There is damaged, loose and missing siding on the west exterior. Recommend repairs by a qualified siding installation specialist.

Loose

Task: Repair

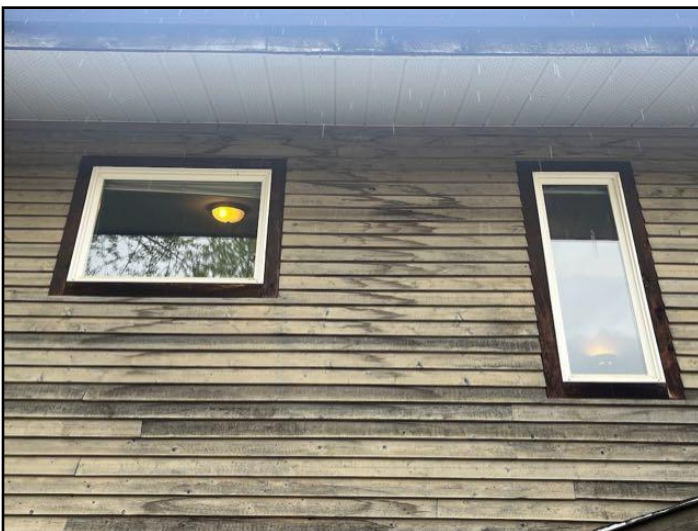
There is water staining evidence on the siding near an upper level north exterior window, and on the South exterior wall. There is water staining above the South side wall staining on the soffit vent. Suspect detail. Possible hidden damage/defects. Recommend requesting a disclosure from the seller about the origins of the water staining and any remedial action taken.

Stained (north)

Task: Request disclosure

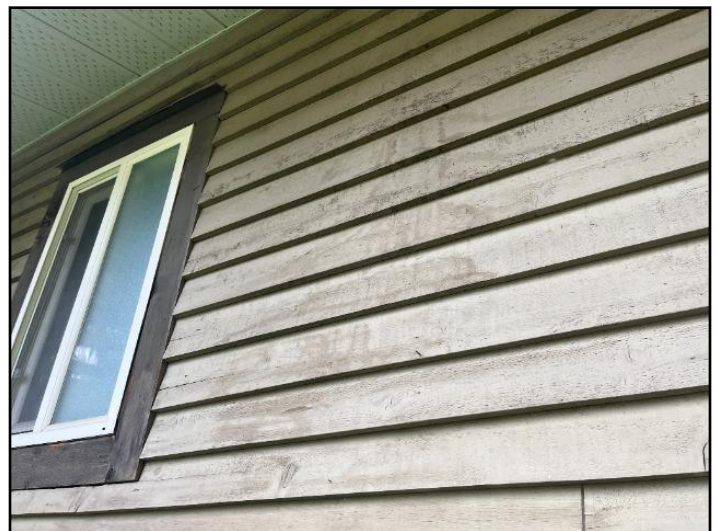
Stained (South)

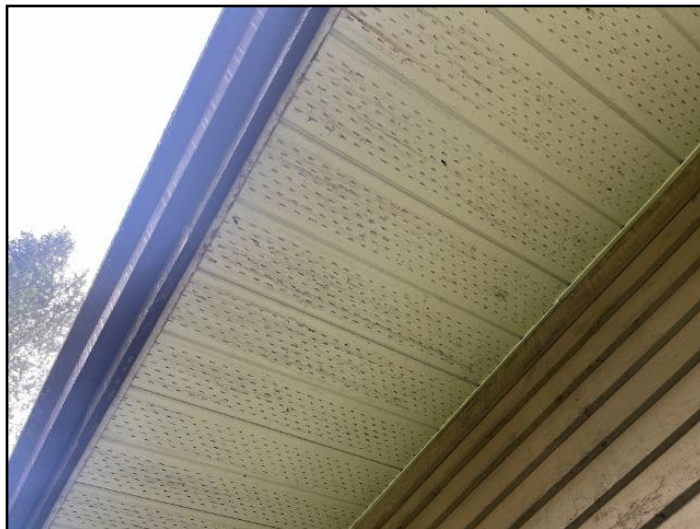
Water staining on the soffit

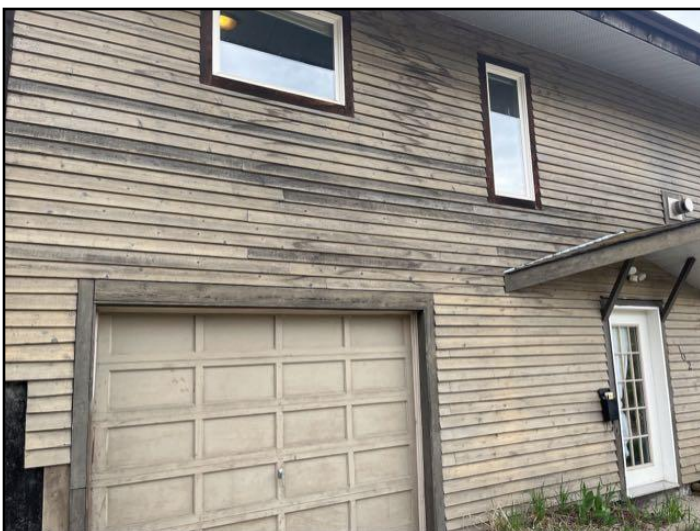
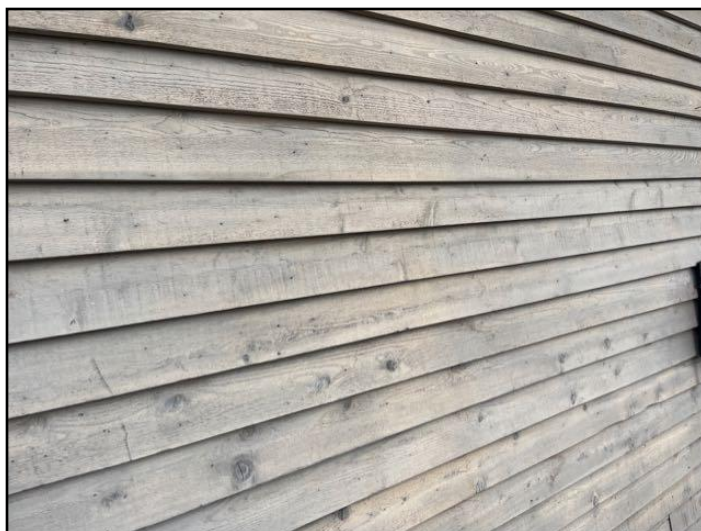
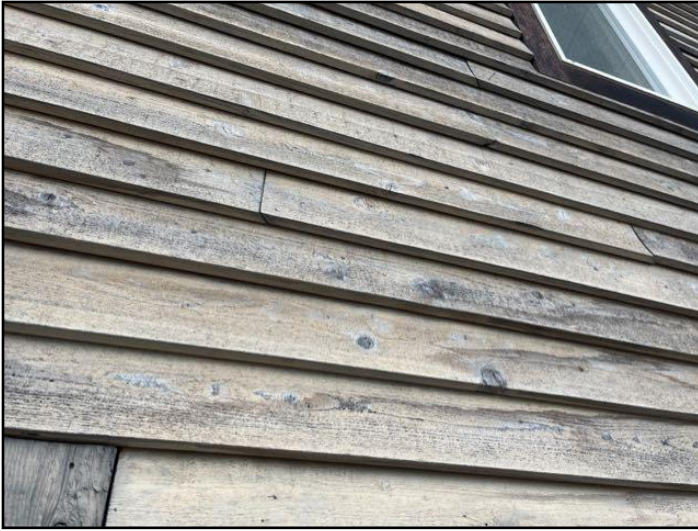
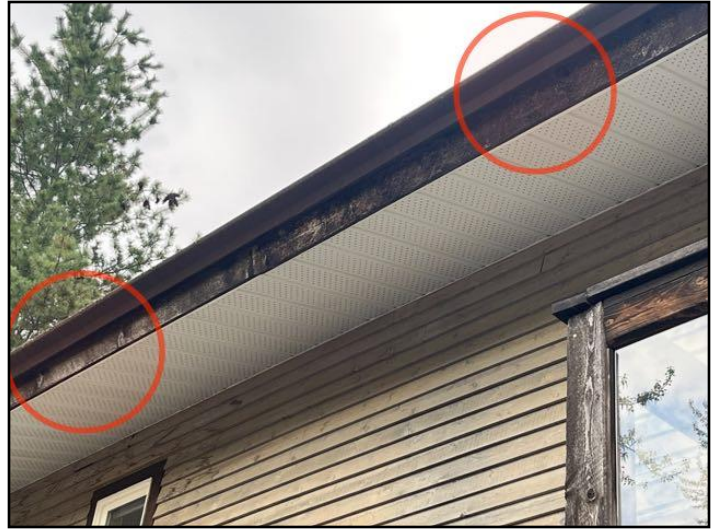
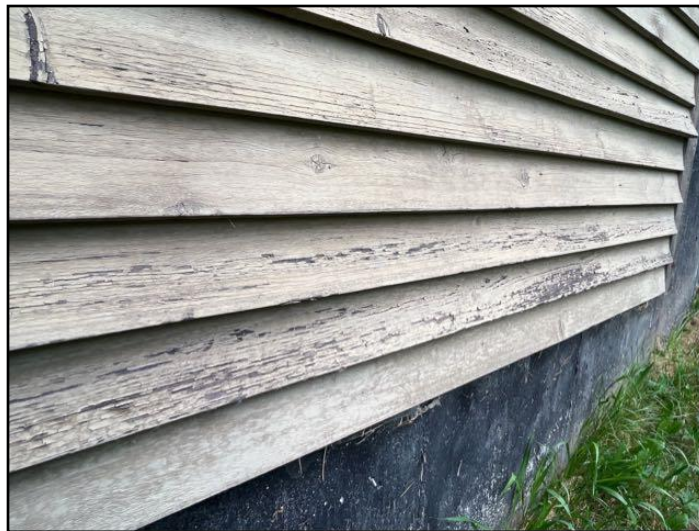
The wood siding, trim and fascia throughout the exterior is lacking maintenance. Paint/stain deficient wood results in increased wear on the siding, and lowered material life expectancy. Recommend adding paint/stain to all exterior wood upon possession, and recommend adding and maintaining paint regularly to help increase the material life expectancy. Possible hidden damage.

Paint or stain - needed

Task: Apply paint/stain

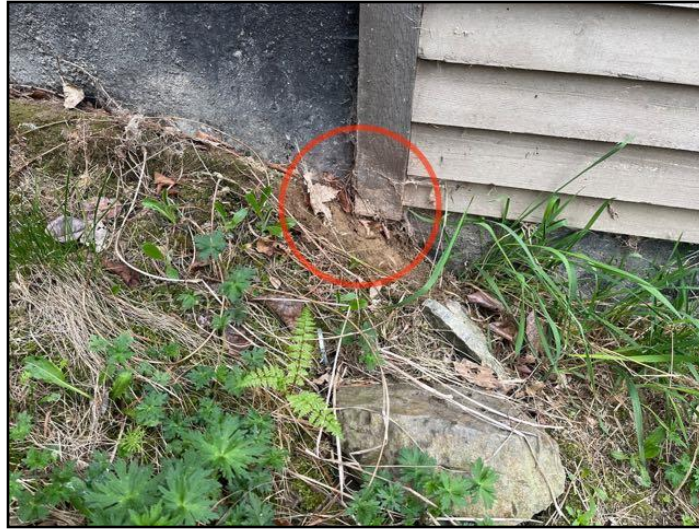
There is wood siding/trim at or near grade. Moisture content and insects from the ground can reduce the life expectancy of the siding. Possible hidden damage/defects.

Too close to grade

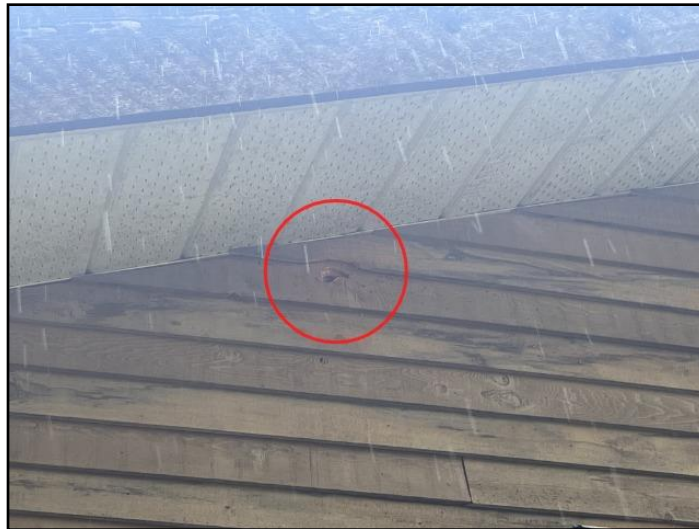
Condition: • There is bird damage to the exterior siding. Chance for water ingress.

Damage

Task: Repair

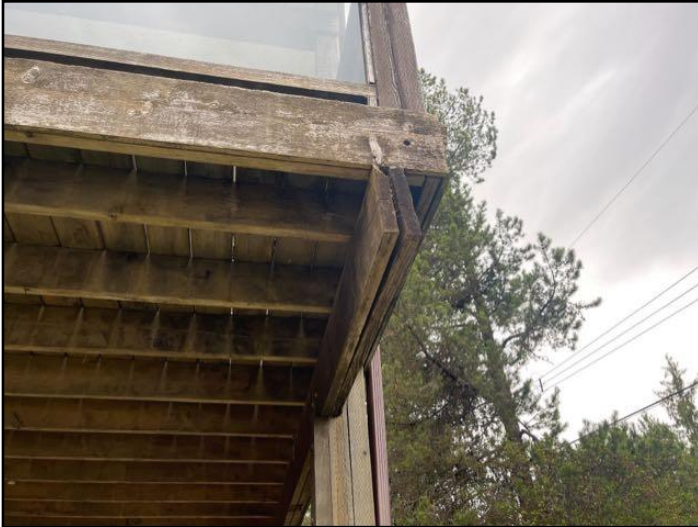
The support beam for the West exterior deck is undersized, pulling apart, rotted and rotated. Reduced structural integrity. Beam/post connection details are inadequate. The centre support post is twisted, which can be linked to the beam rotation. Recommend replacing the beam with a larger beam that has adequate connections to the posts. A qualified Carpenter is recommended to make these repairs, who will provide quotes for associated costs.

Rotation

Task: Replace beam and improve connections

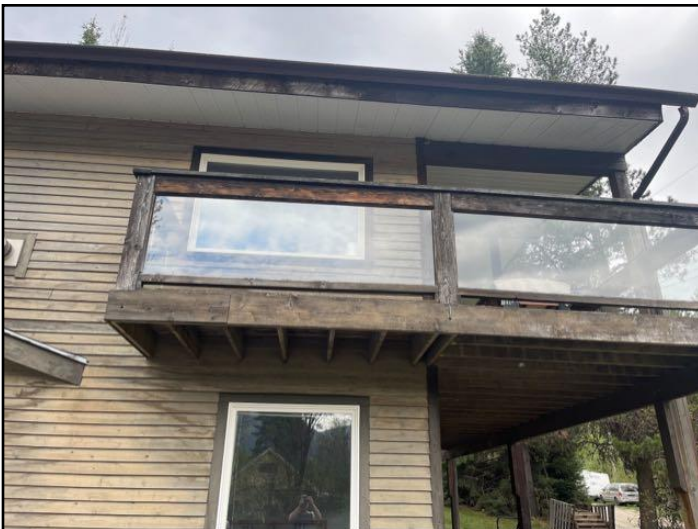
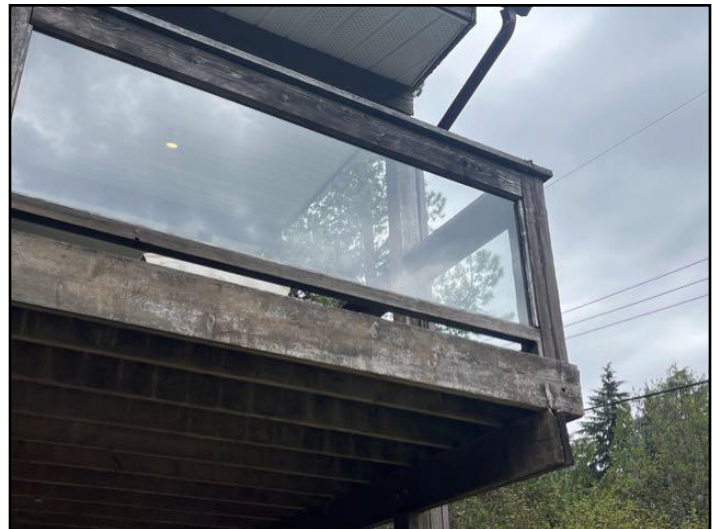
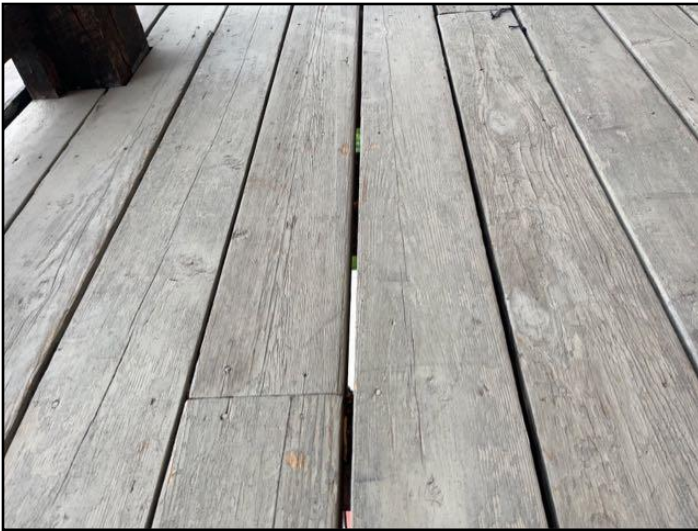
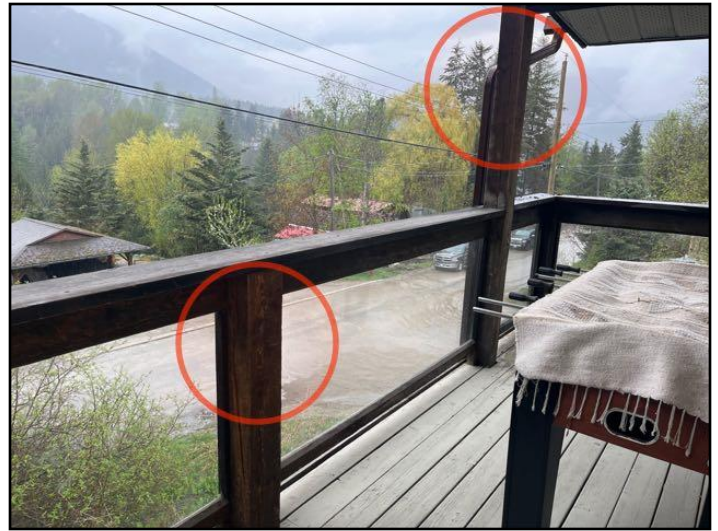
There is deferred maintenance throughout the exterior deck components. Paint/stain should be regularly applied to the exterior wood. Exterior wood that does not have paint/stain regularly applied has a reduced life expectancy.

Paint or stain needed

Task: Add and maintain paint/stain

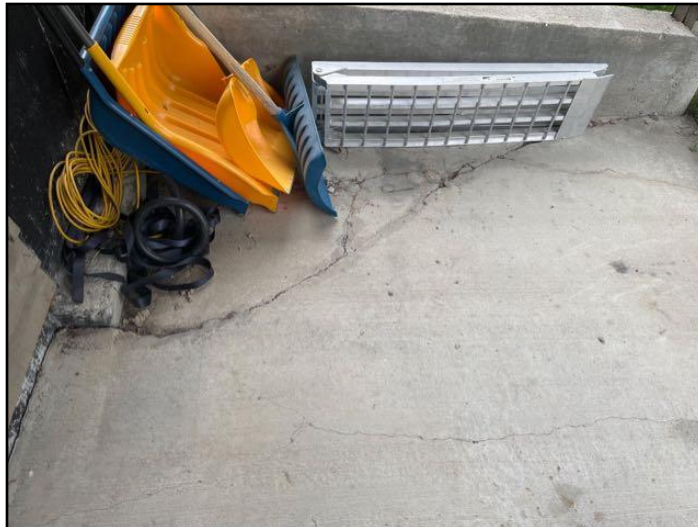
There is cracking and settlement in the west exterior concrete patio slab. Possible hidden defects. Recommend repairs by a qualified concrete repair specialist who will provide quotes for associated costs.

Cracked or damaged surfaces

Task: Repair

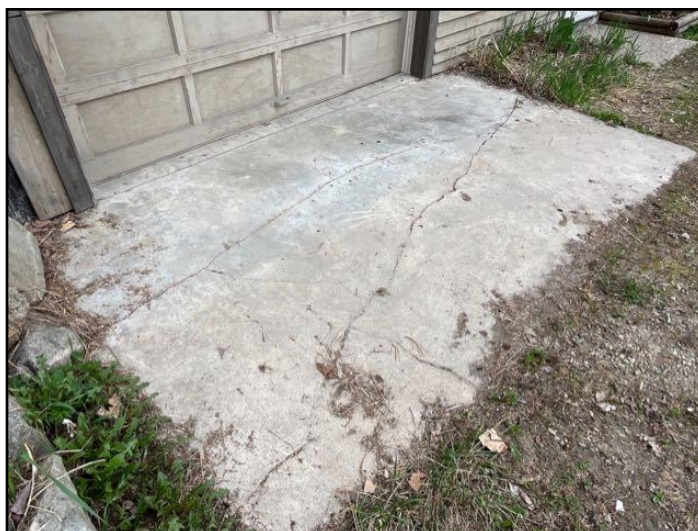
The north exterior garage floor apron is cracked/damaged. It is recommended to retain a qualified concrete repair specialist to repair and seal the cracks to reduce the chance of further material deterioration.

Cracked

Task: Repair and Seal cracks

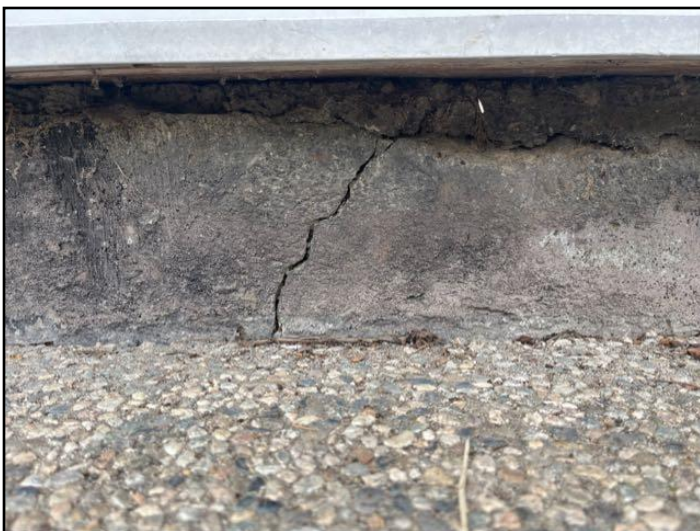
There are moderate sized foundation cracks in the visible portions of the concrete foundation, one of which appears to have been previously sealed. A qualified foundations repair specialist is recommended to repair/seal the cracks. Possible hidden damage/defects. Repairs may be costly.

Cracked (north)

Task: Repair and Seal

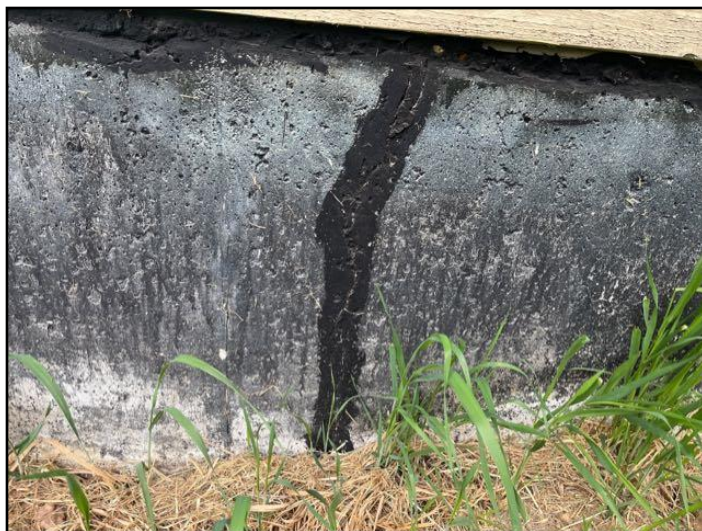
Cracked (south)

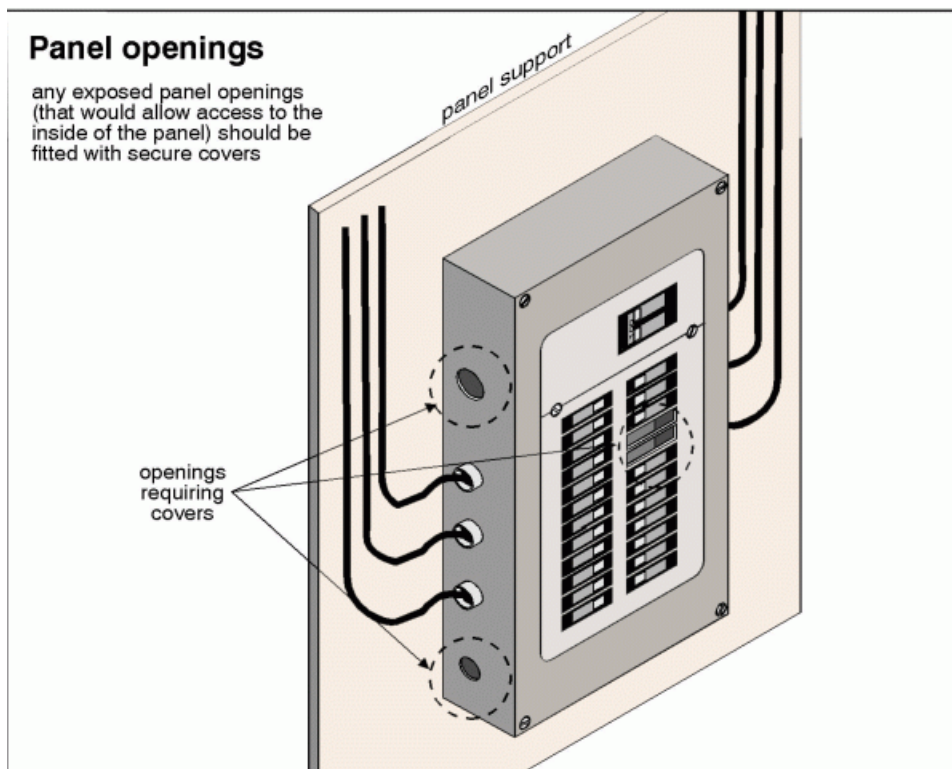
There is an unprotected opening in the electrical panel. Recommend installing breaker covers.

Task: Repair

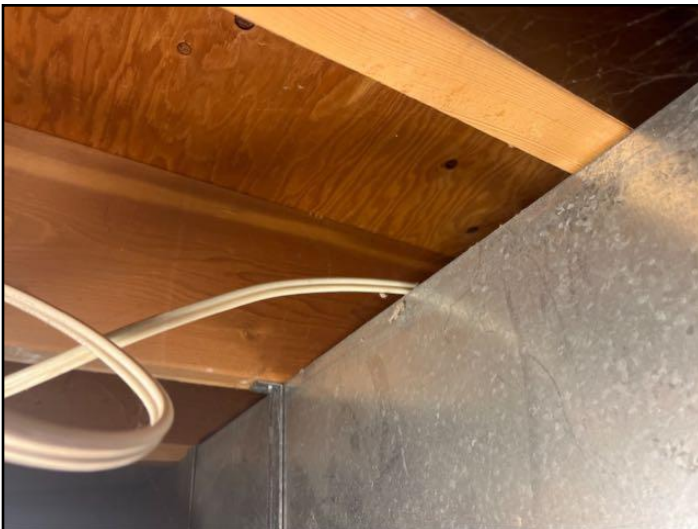
Condition: • Wires noted touching duct work. Should the sheathing of the wire deteriorate or get damaged there is potential for the wire to "liven" the duct work. This is a safety concern. Recommend re-routing wiring or adding an insulation barrier to separate wires from the ducting.

Wires noted touching duct work. Should the...

Task: Ensure wires do not contact ducting

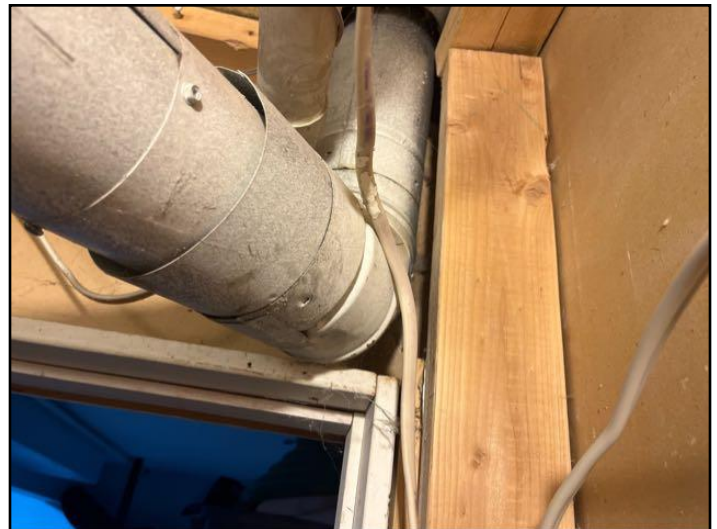
Contacting the furnace vent pipe (high heat)

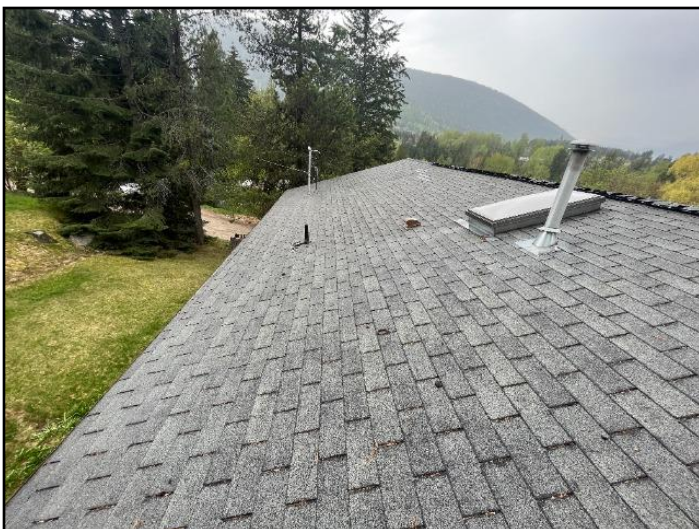
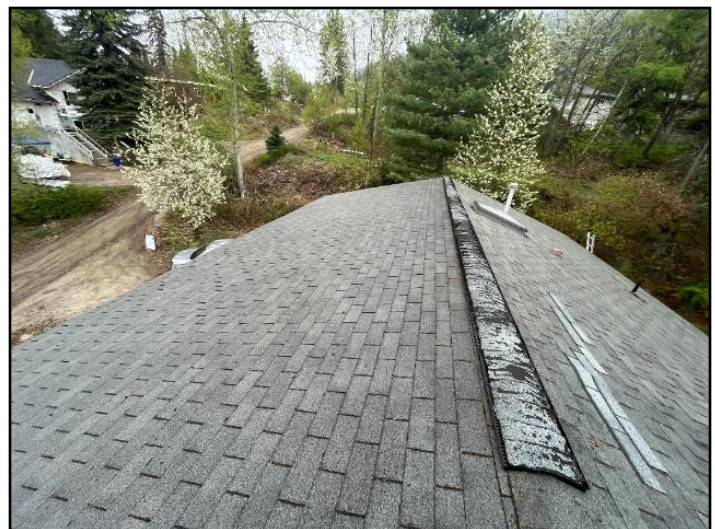
There is minimal attic ventilation noted on the roof of the home. Soffit venting surrounds the underside of the roof overhang, but the only vent on the roof is the ridge vent. This may be an inadequate amount of attic ventilation, that could result in potential moisture damage and organic growth to the roof sheathing/framing. It is recommended that when the roof is being replaced next, that several roof sheathing sheets are pulled up to examine the underside of the sheathing to determine if there is any attic staining present. IF attic staining is present (dark speckling/blackened roof sheathing), an indoor air quality specialist is recommended to determine the cause, and provide direction and quotes on remedial

Missing vents

action, if necessary. Several roof vents should also be added to the roof of the home when the roof is being replaced to ensure adequate air flow and attic ventilation.

Task: Improve

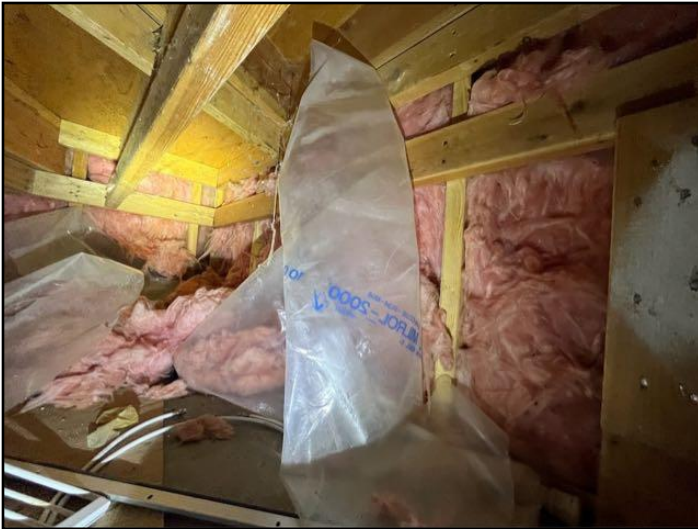
The vapour barrier and insulation in the under stair storage space on the bottom floor is loose. Recommend replacing the insulation and repairing the vapour barrier.

Incomplete

Task: Repair

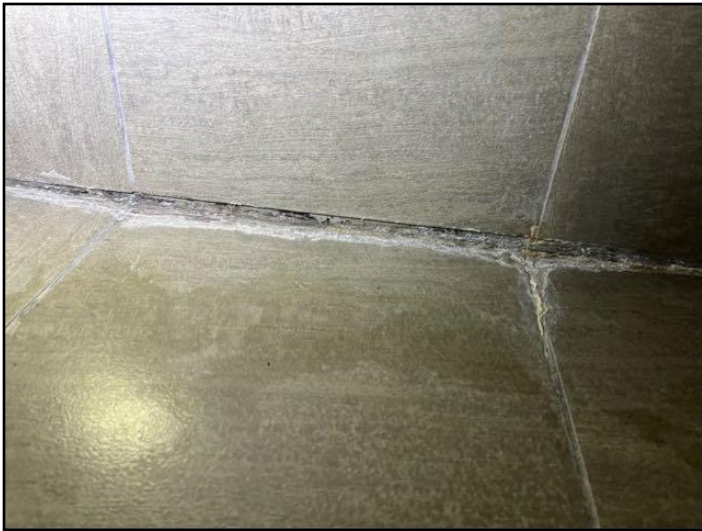
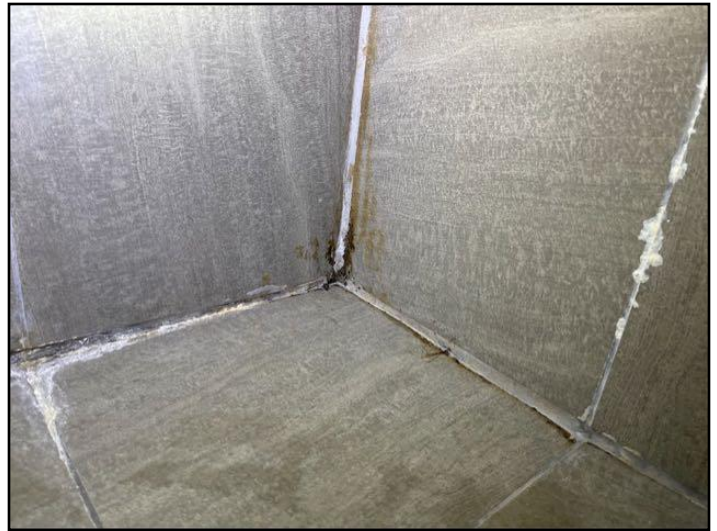
There is high moisture readings on all three walls in the lower level shower. There is moisture staining along the bottoms of the walls. High moisture readings on the shower walls may indicate the potential for hidden damage behind the tiles. Recommend retaining a qualified Tiler/ interior finisher to further evaluate the extent of the moisture penetration and potential hidden damage, who will provide quotes for associated costs. Repairs may be costly.

Moisture staining

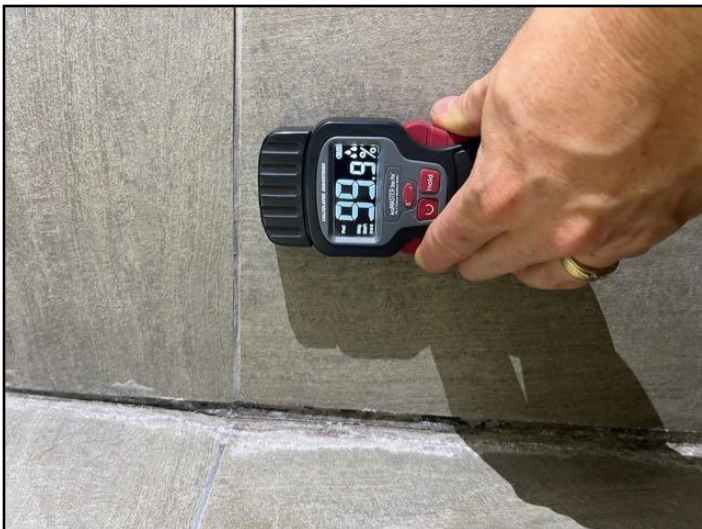
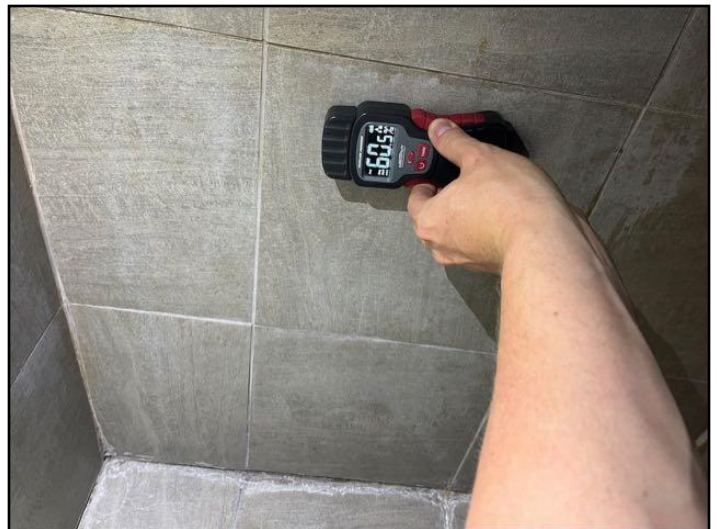
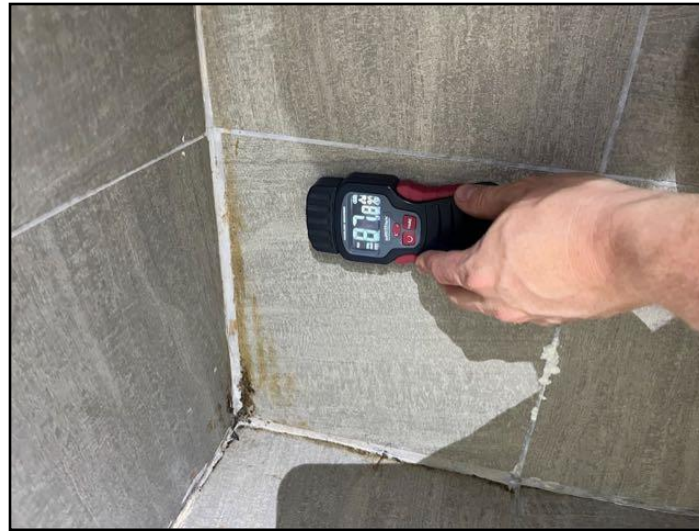
High moisture

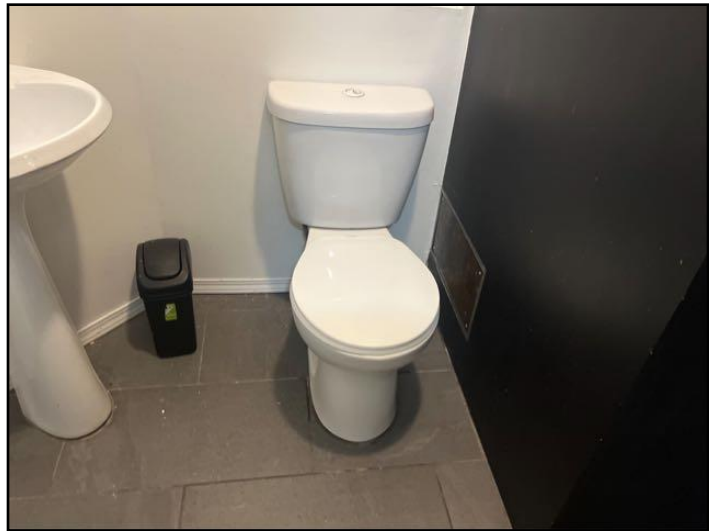
There is a loose toilet. Possible hidden damage. Loose toilet pose an increased risk of leakage and corresponding potential damage.

Loose

Task: Improved fastening/repairs

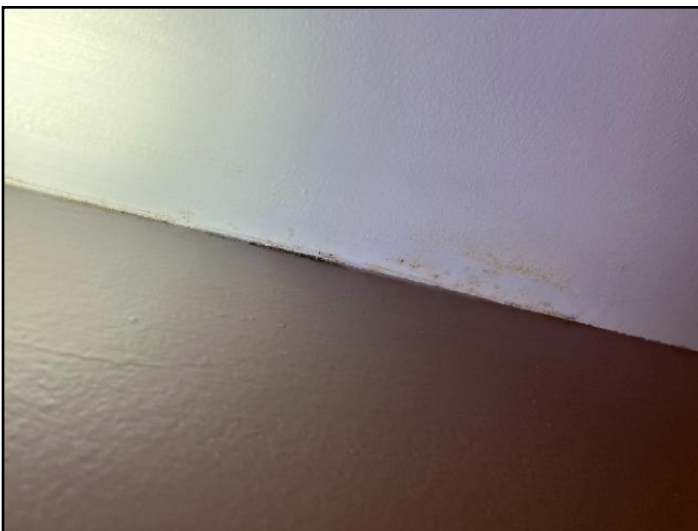
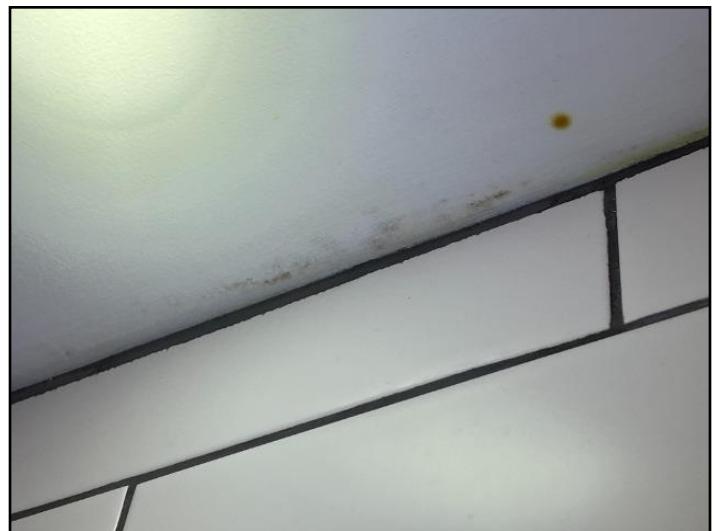
Stains

Task: Clean
