YOUR INSPECTION REPORT

Timberline Home Inspections. Your trusted, reliable Kootenay Inspection service!

123 Main Street
Nelson, BC V1A 1A1

Saturday, April 15, 2023

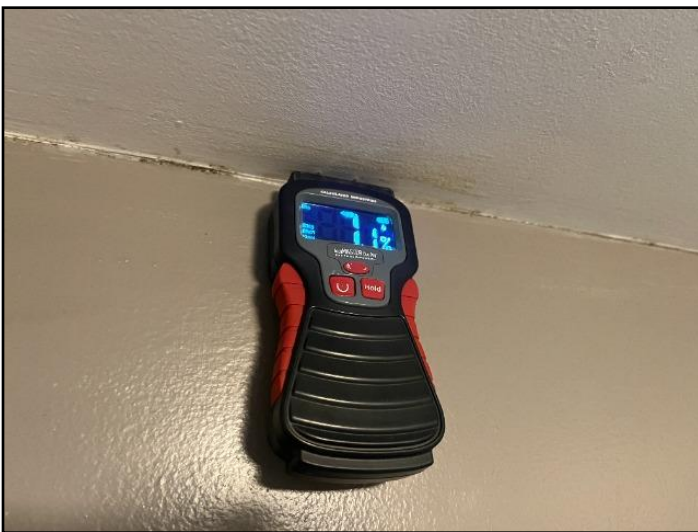
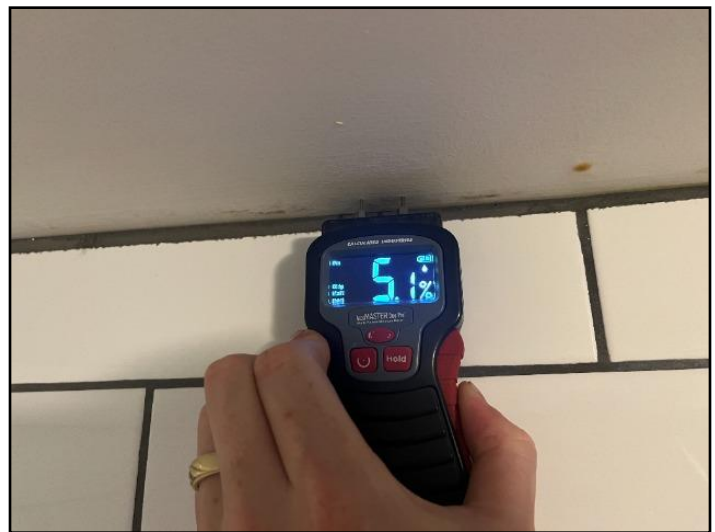
Low moisture

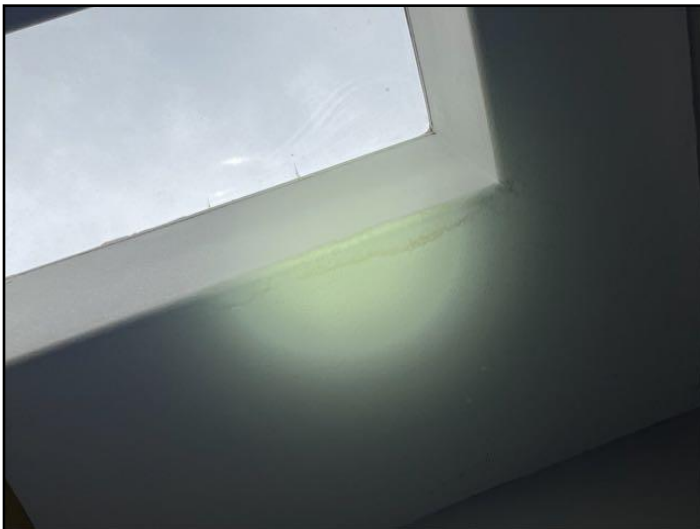
Water stains

Task: Repair

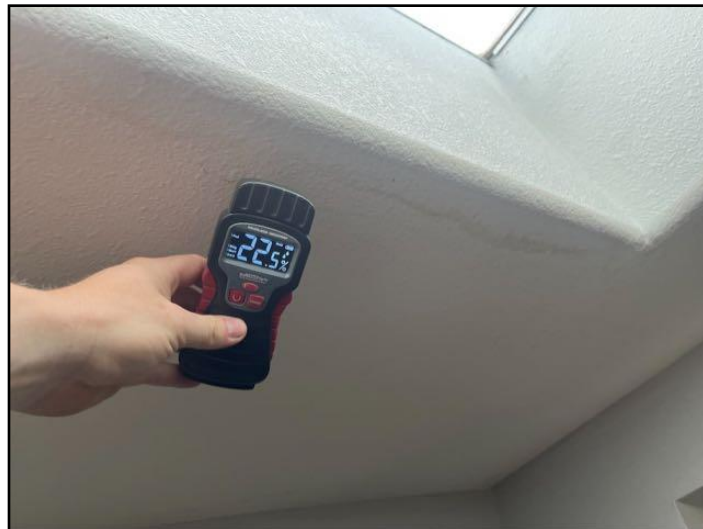
Elevated moisture

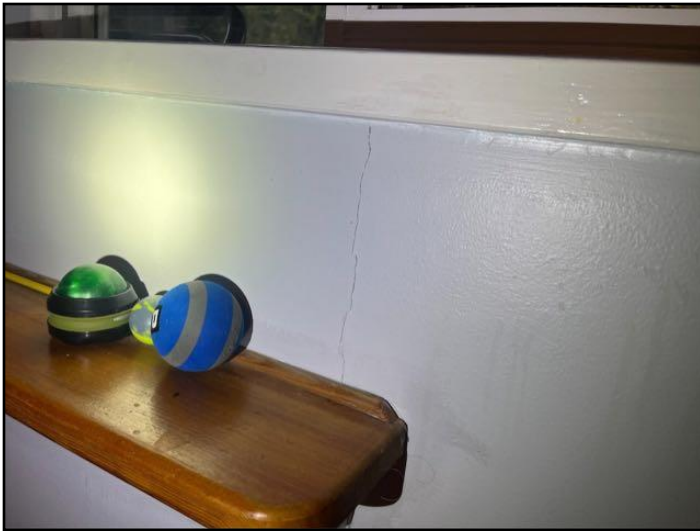
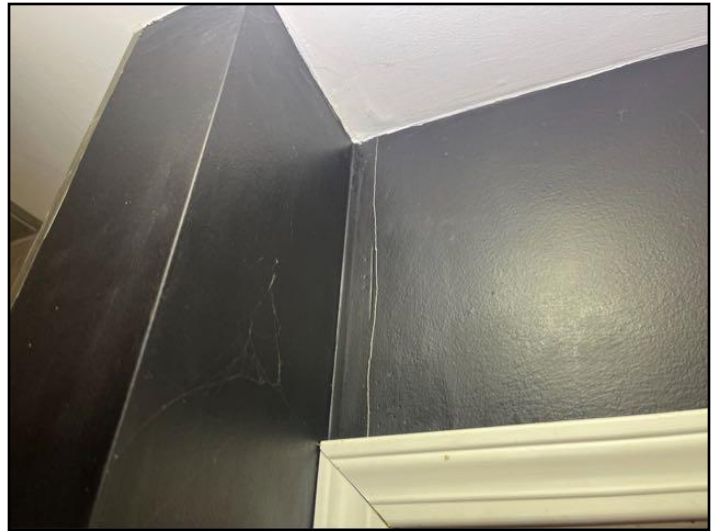
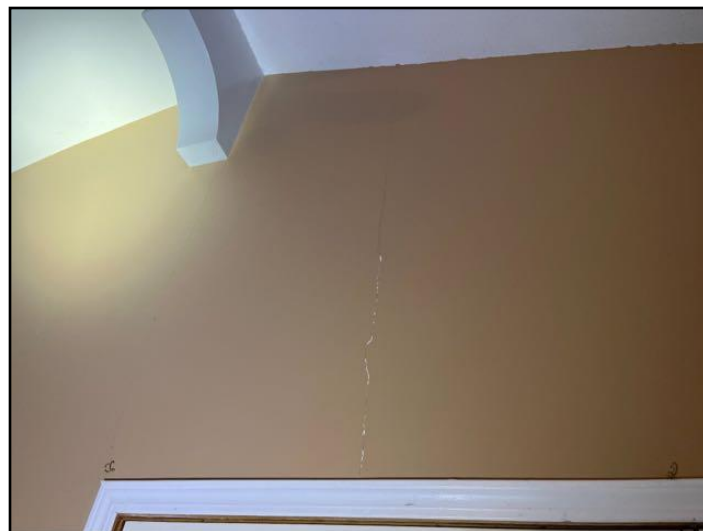
Cracks

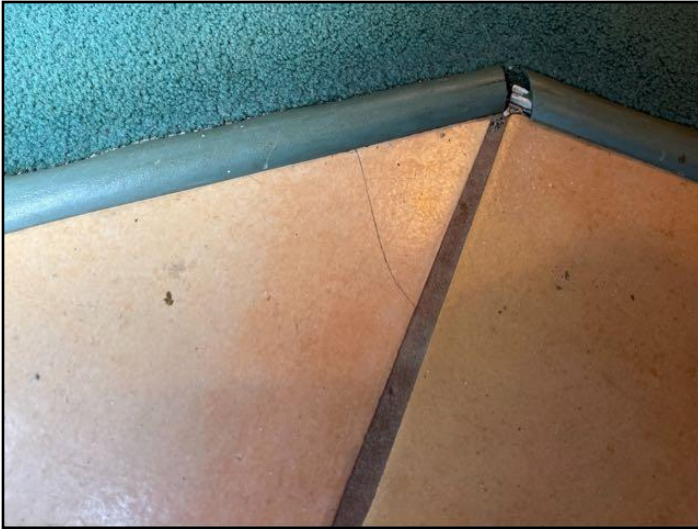
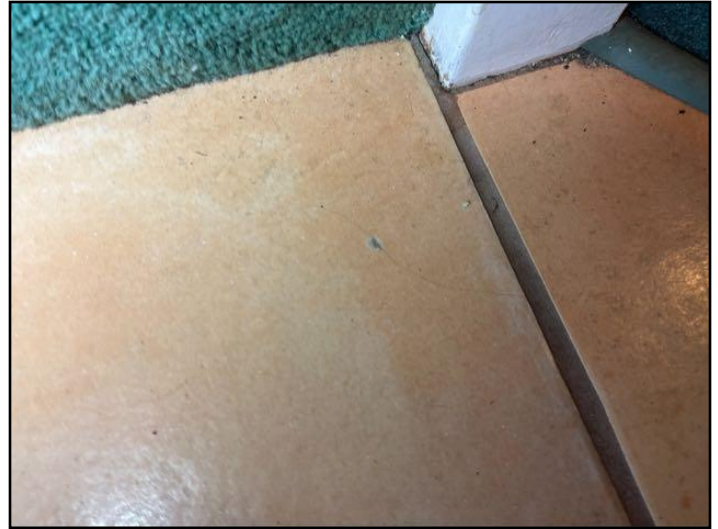
Tiles cracked

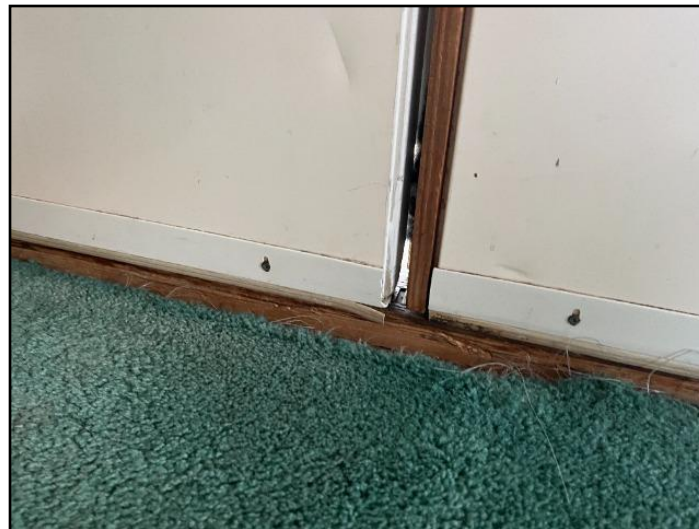
Loose or poor fit

Task: Repair
