PROPERTY CONDITION ASSESSMENT REPORT

Timberline Home Inspections. Your trusted, reliable Kootenay Inspection service!

123 Main Street
Timberline, BC A1A 1A1

Friday, April 1, 2022

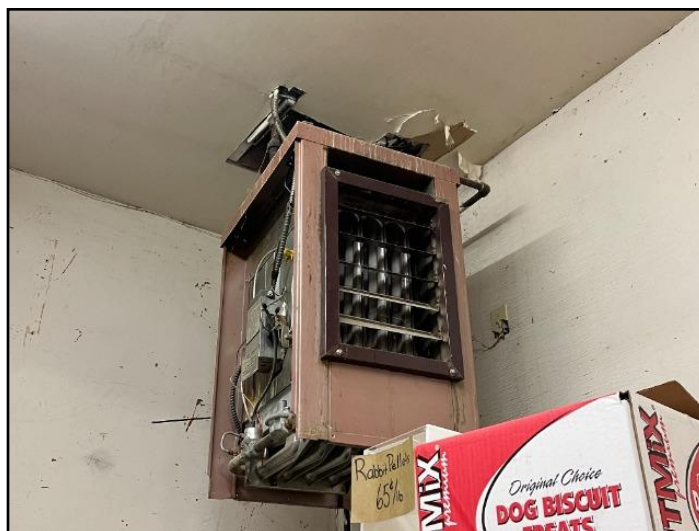
Buildingcenter.org places unit manufacture at 1964- 58 years.

Gas-fired, unit heater

Noted poor condition ceiling mounted heater. Buildingcenter.org places date of manufacture as 1964. Past typical life expectancy. No function on day of inspection when nearby thermostat was operated. Possible hidden defects/damage. Possible equipment does not function. Recommend repairs/replacement.

Task: Repair or replace

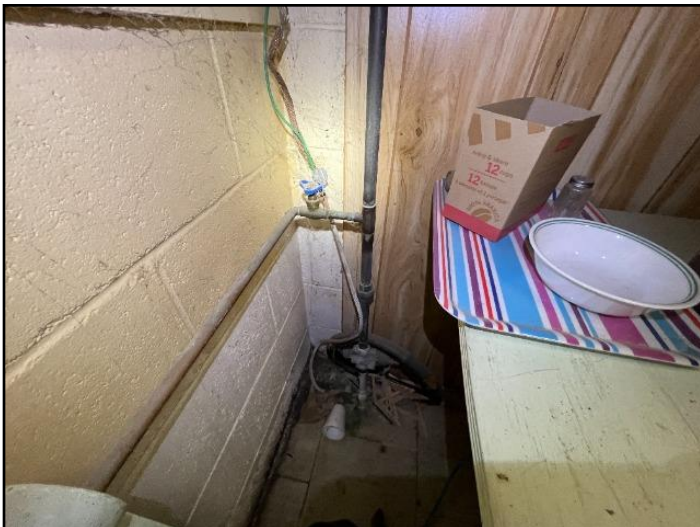
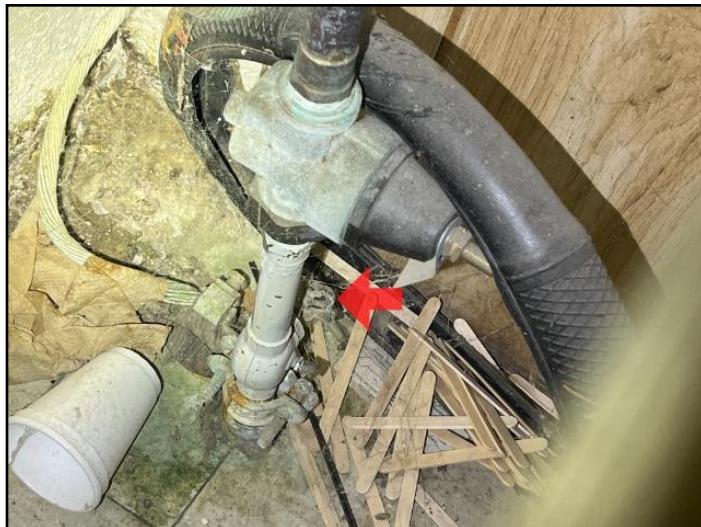
In the mechanical room

Backflow Prevention Device at the main water supply: • None

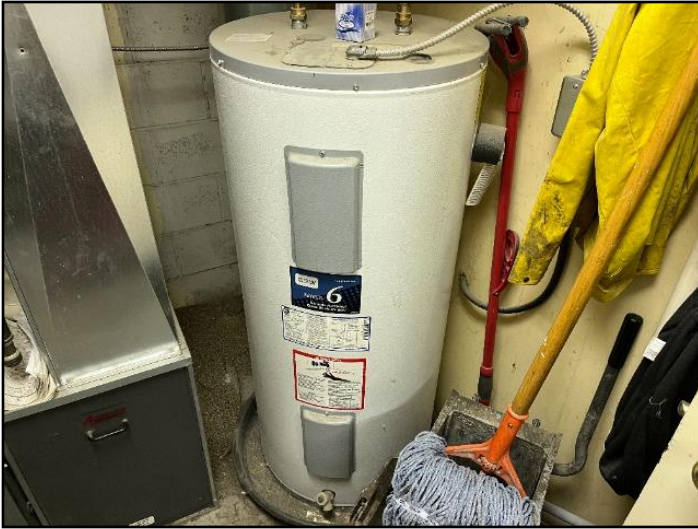
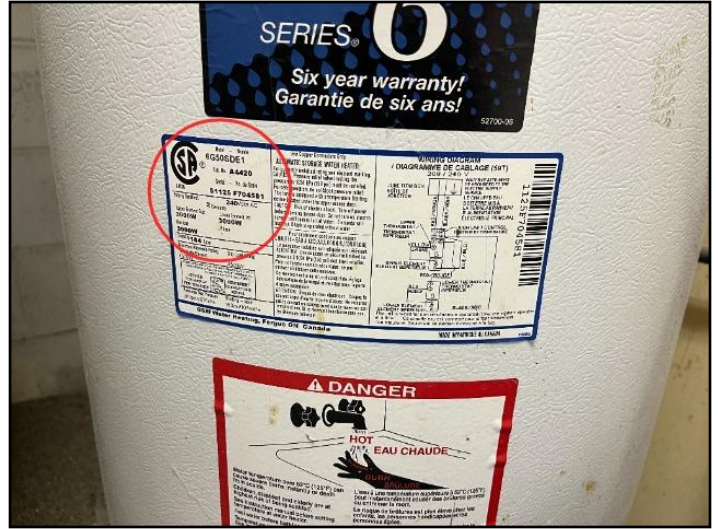
Between 10 and 15 yrs old

Noted the date of manufacture on the hot water tank as 2011. 11 years. Typical life expectancy 8-12 years. Recommend budgeting for replacement.

Task: Replace
