YOUR INSPECTION REPORT

Timberline Home Inspections. Your trusted, reliable Kootenay Inspection service!

123 Main Street
Nelson, BC V1A 1A1

Saturday, April 15, 2023

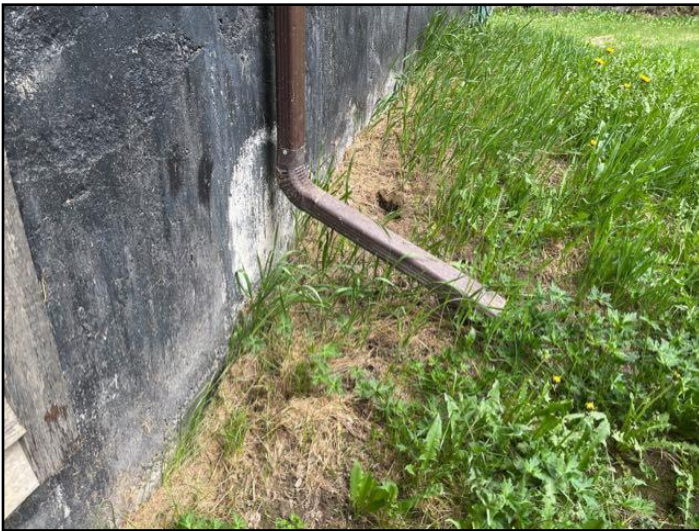
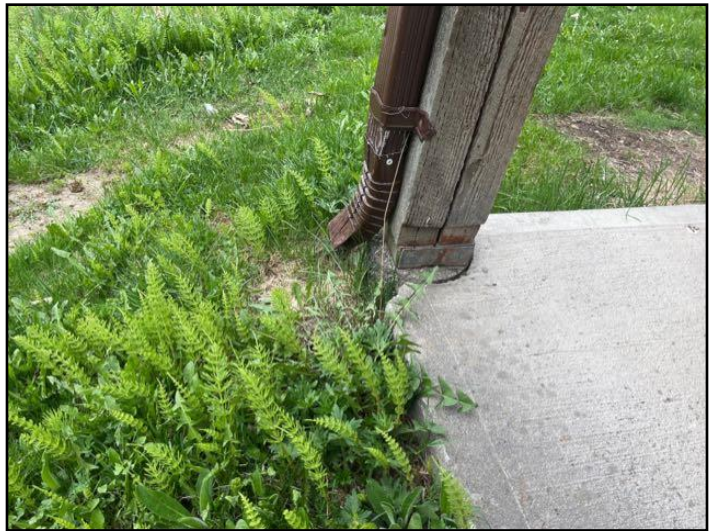
Discharge too close to building

Task: Extend downspouts

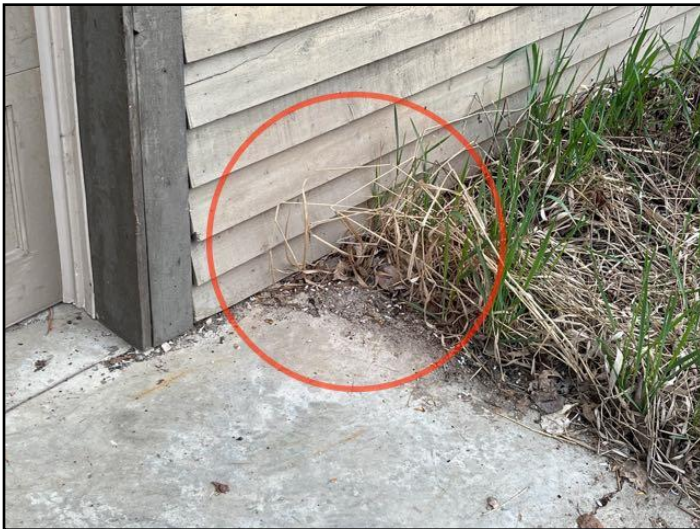
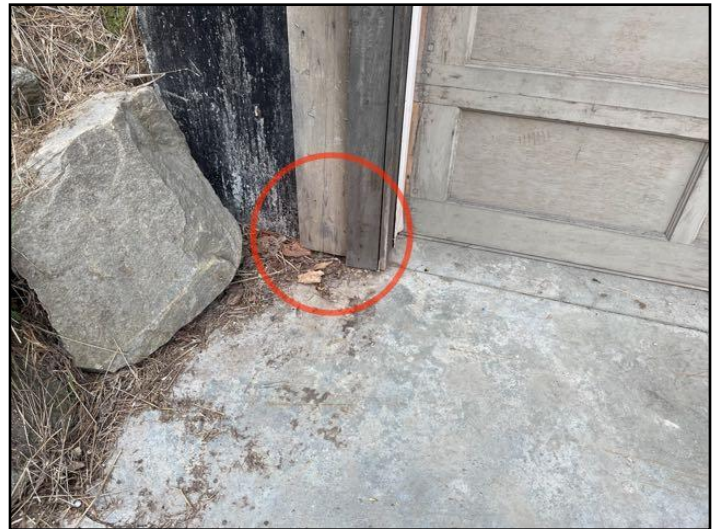
Too close to grade

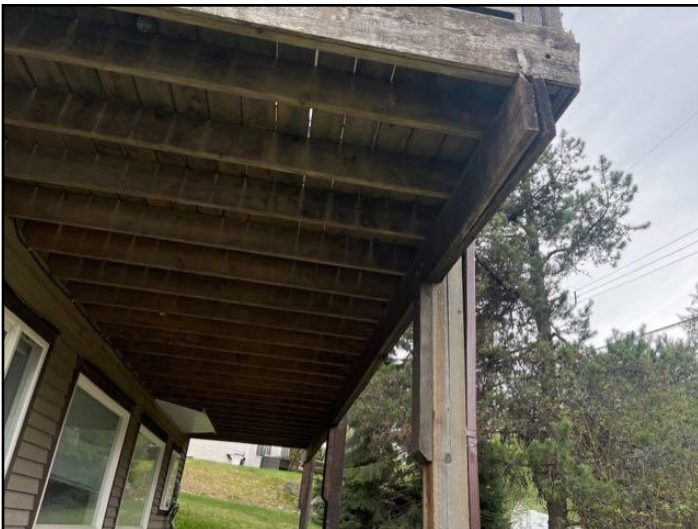
Poor post connection

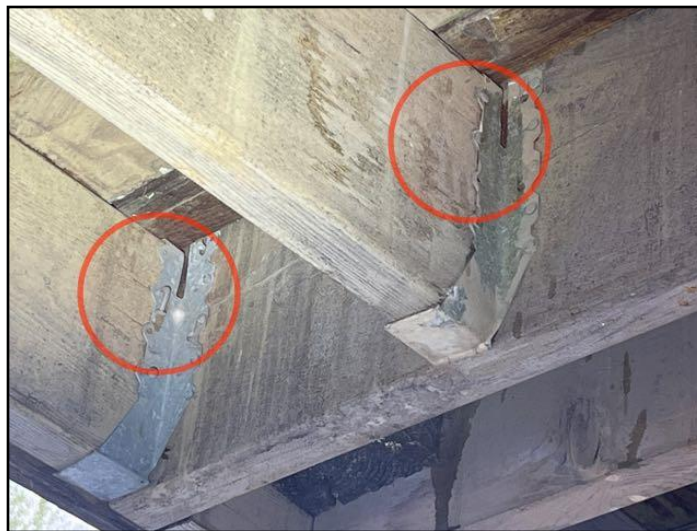
Poor end bearing, joist hanger connections

Task: Improve

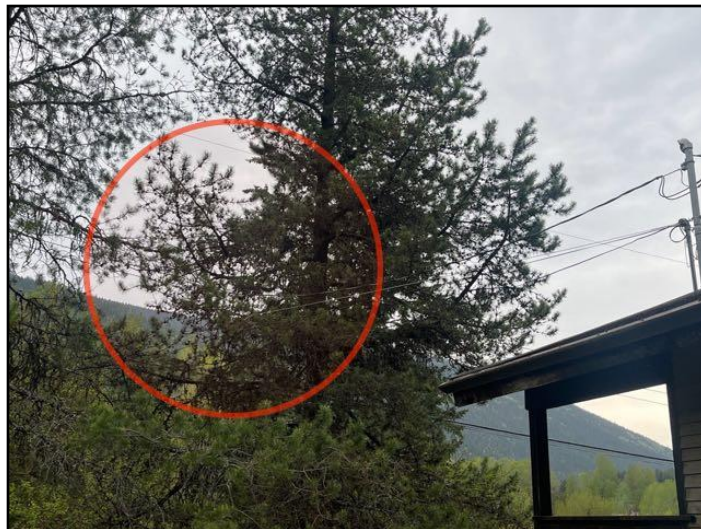
Branches / vines interfering with wires

Task: Improve

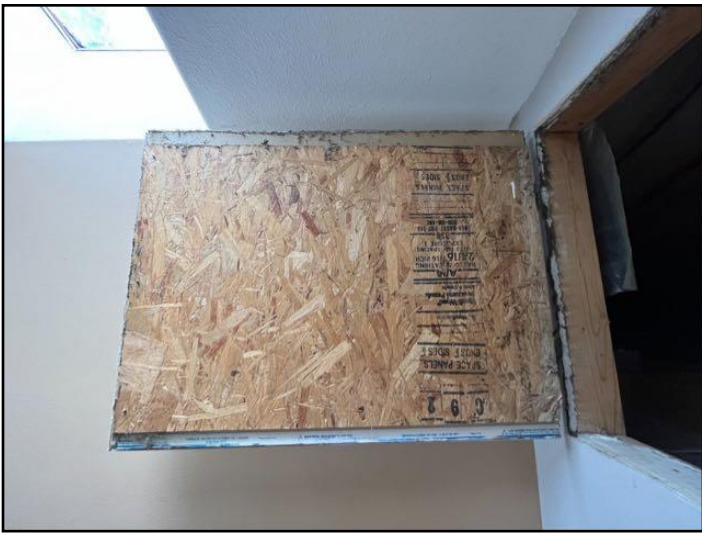
Missing insulation and weatherstripping on the attic hatch.

Not insulated and not weatherstripped

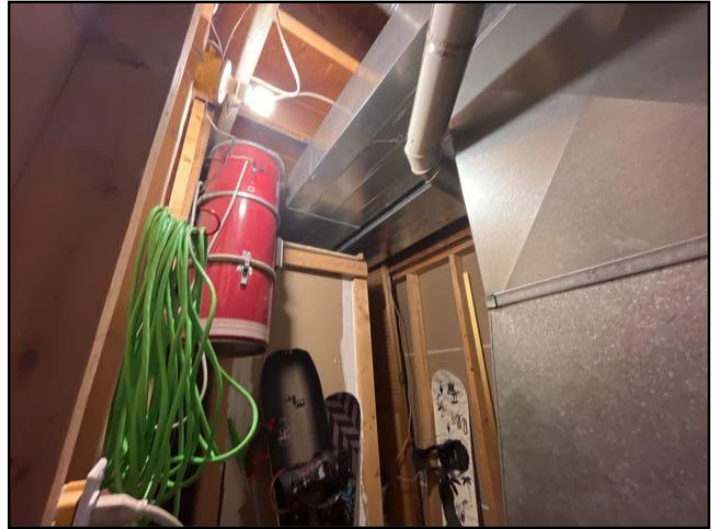
not gas tight
