YOUR INSPECTION REPORT

Timberline Home Inspections. Your trusted, reliable Kootenay Inspection service!

123 Main Street
Nelson, BC V1A 1A1

Saturday, April 15, 2023

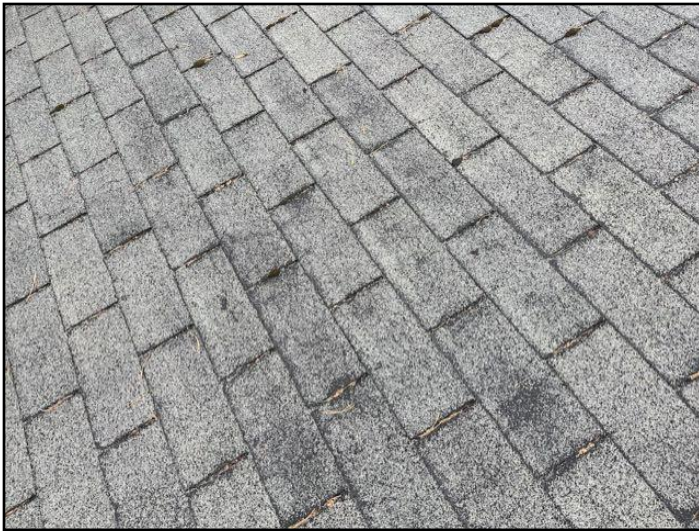
There are multiple deficiencies throughout the roof surface. Noted granule loss, patches, damaged shingles, ridges in the roof surface, and ridge shingles that are worn to the shingle mat. Roof shingles that are in this condition pose an increased risk of leaking and corresponding water damage to the structure/finishes. Recommend retaining a qualified roofer for roof replacement who will provide quotes for associated costs.

Granule Loss

Task: Replace

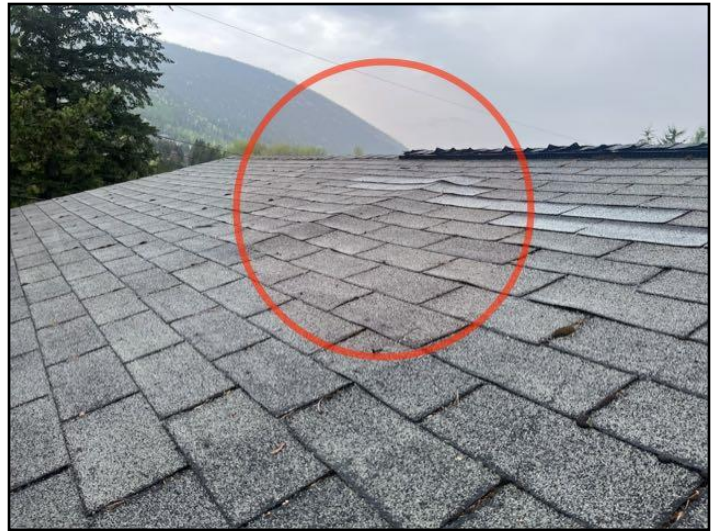
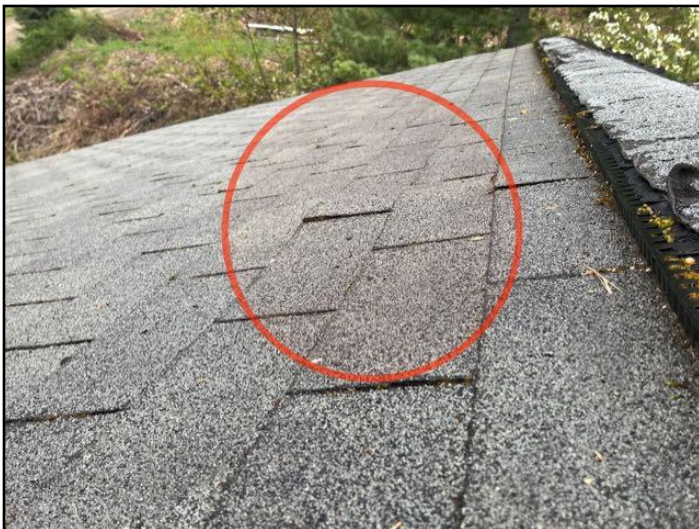
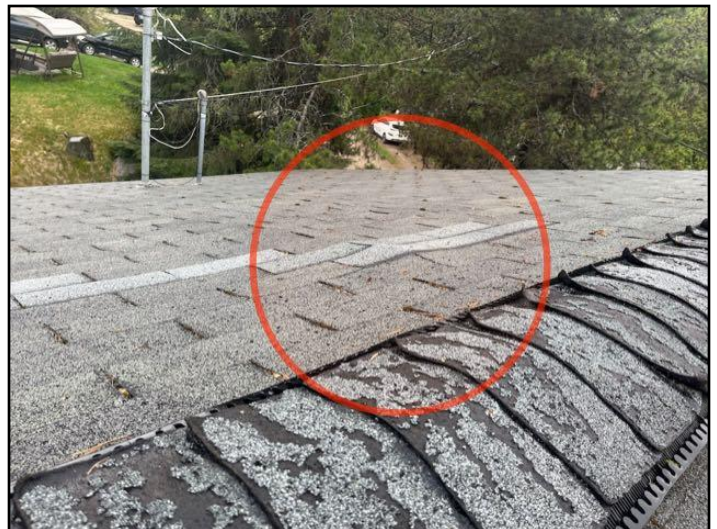
Suspect ridge

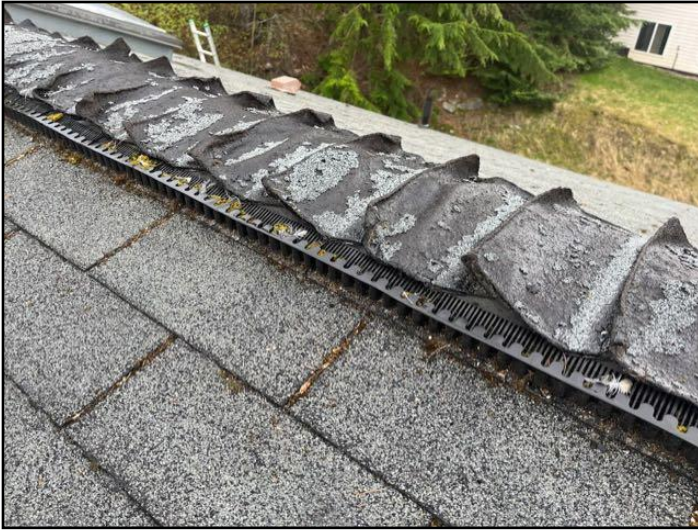
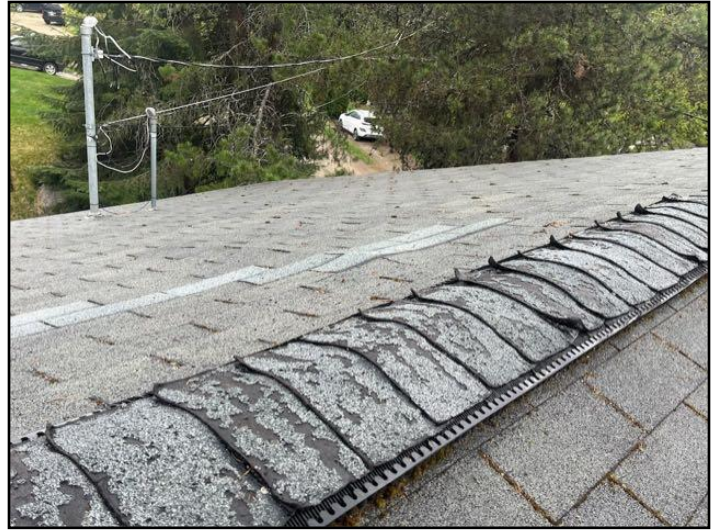
Near end of life expectancy

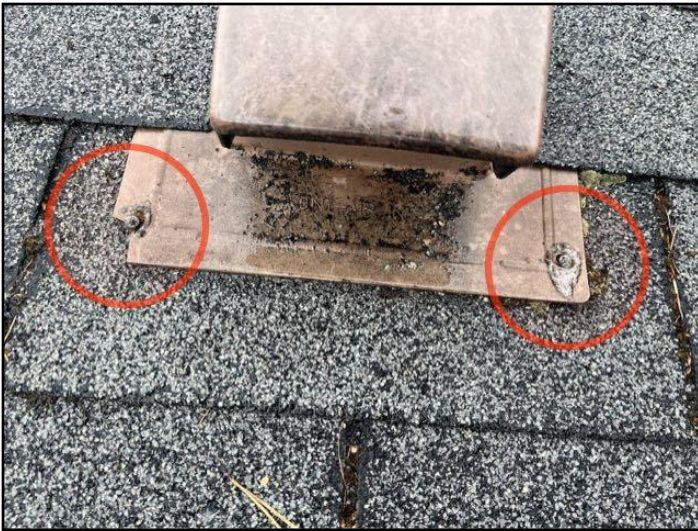
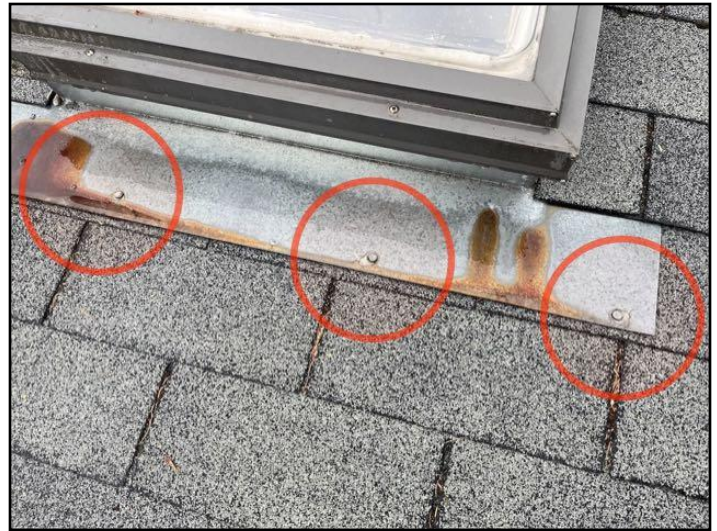
There are exposed fasteners on the roof flashings. Recommend applying a high-quality sealant to the fastener heads to reduce the chance of water ingress.

Exposed fasteners

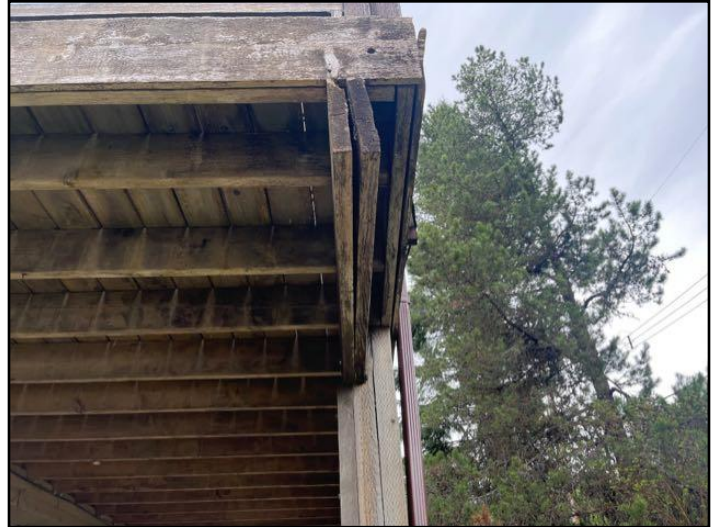
Pulling apart

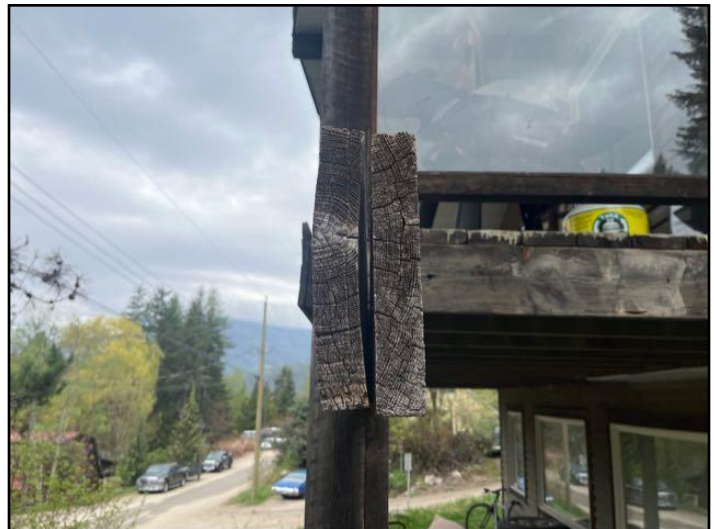
Separating

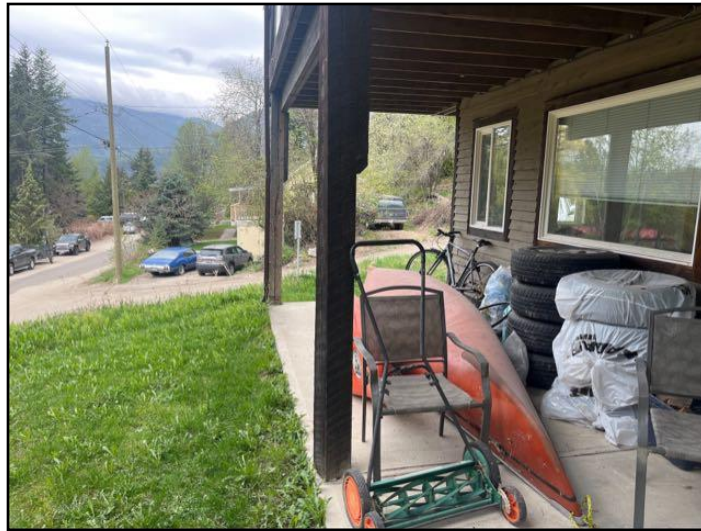
Twisted post

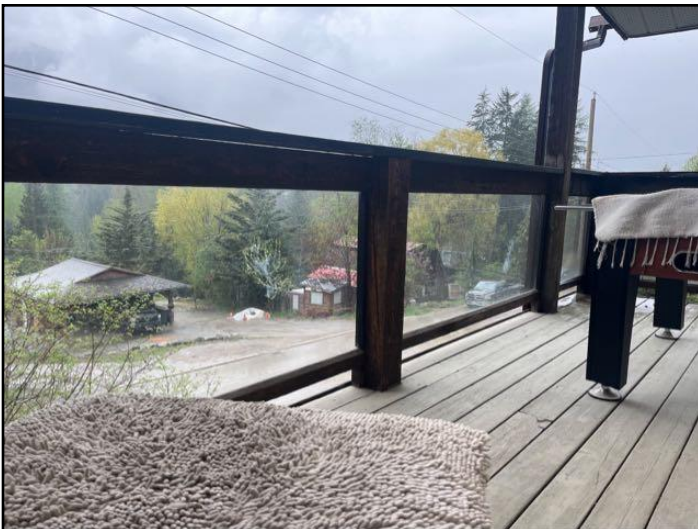
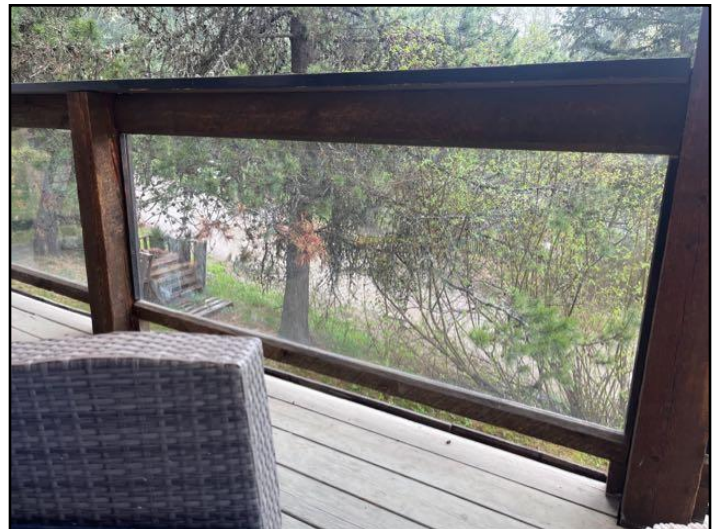
Safety or tempered glass needed

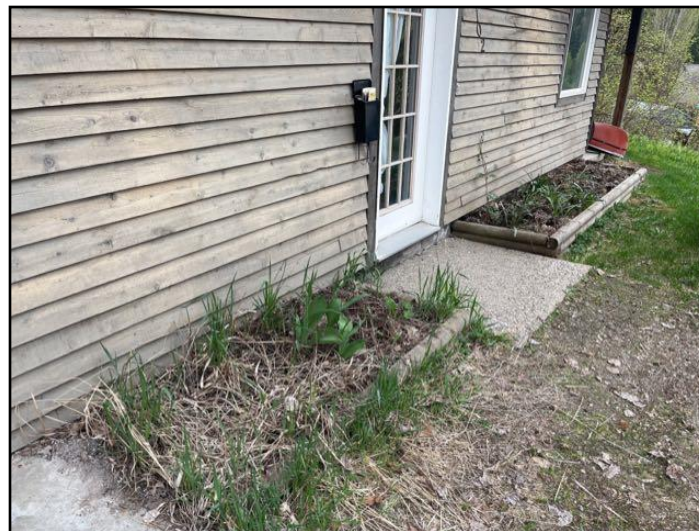
Planters and gardens against walls

Task: Remove

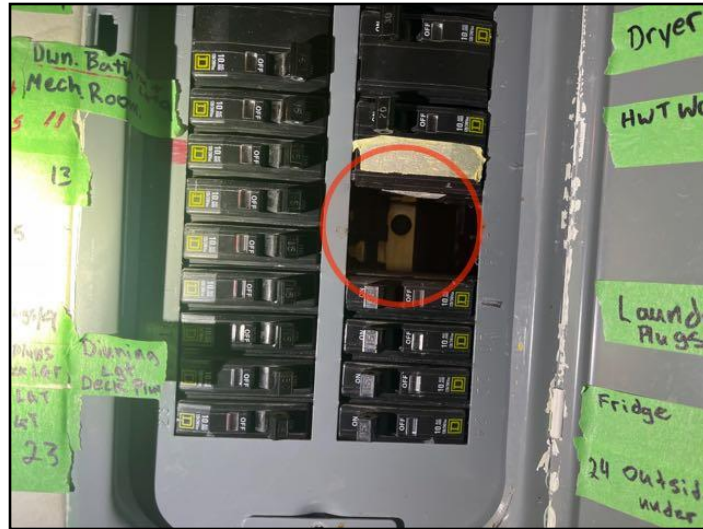
Openings in panel

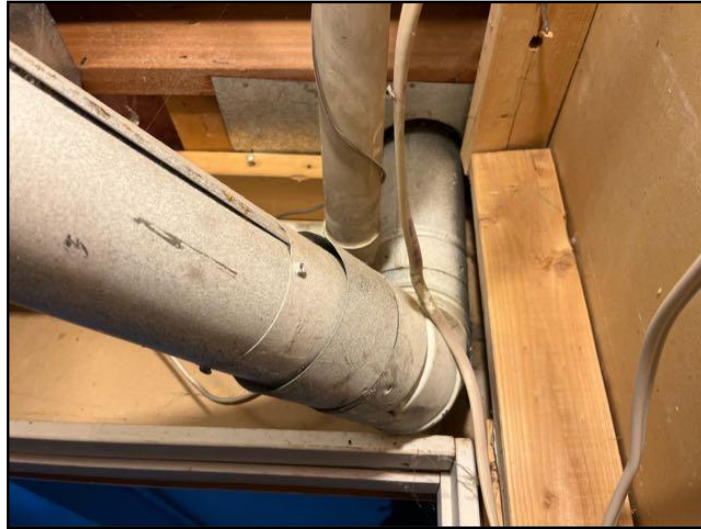
The furnace vent does not appear to meet combustible clearance requirements. Fire/safety hazard. Recommend retaining a qualified HVAC specialist for immediate improvements.

Combustible clearance

Task: Improve clearances

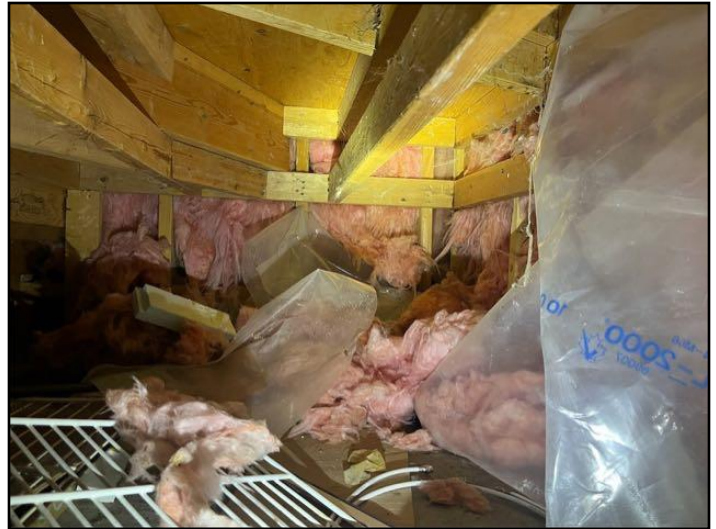
The vapour barrier and insulation in the under stair storage space on the bottom floor is loose. Recommend replacing the insulation and repairing the vapour barrier.

Incomplete

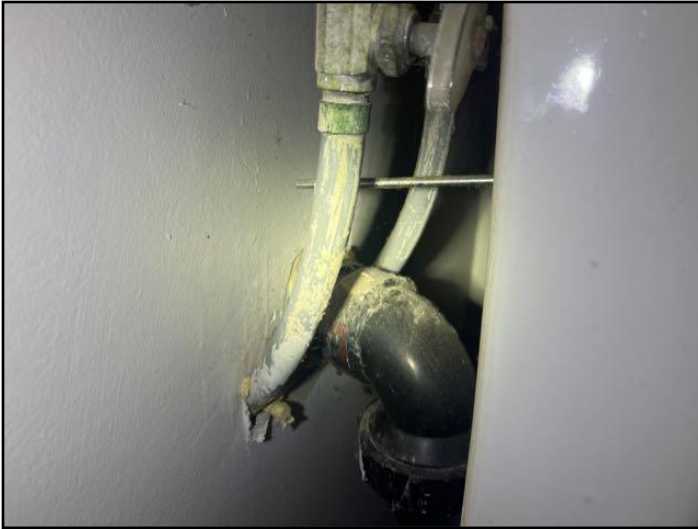
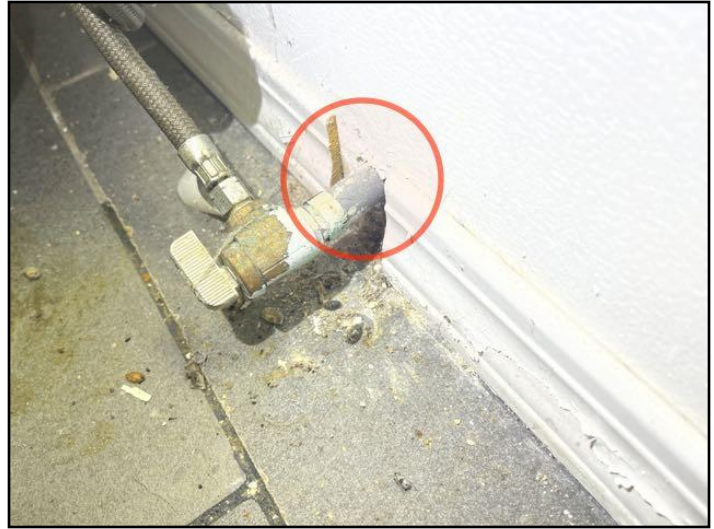
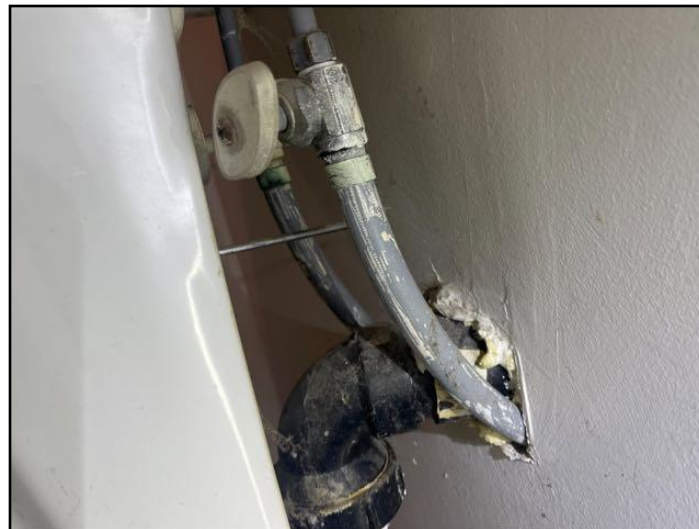
Polybutylene distribution piping present in the home. Polybutylene is a more vulnerable pipe material to failure than other materials (like copper and PEX). The results of this increased vulnerability are the potential for hidden damage, and possible insurance implications. It is recommended to further evaluate with insurance providers, and a qualified Plumber should be retained for further evaluation as to the extent of the Poly-B, and provide quotes for corresponding Plumbing upgrades.

Polybutylene

Task: Further evaluation

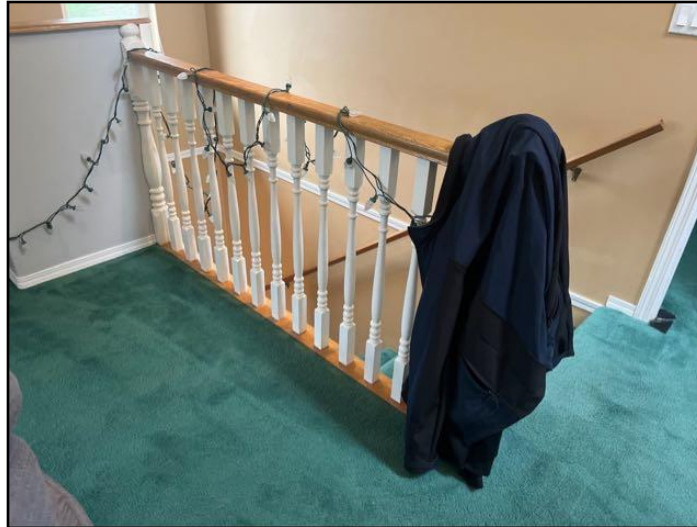
Loose

Task: Repair

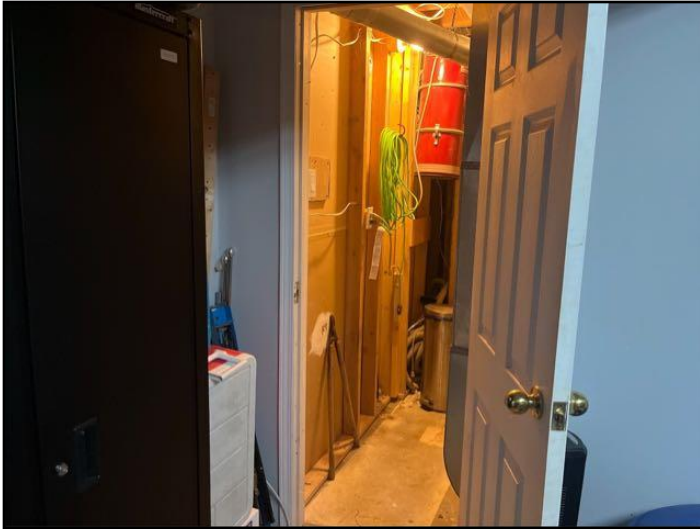
No self closer
